# Focus Group

Facility Study & Master Planning Services  
Markesan District Schools

September 20, 2023

District-wide Facilities Study

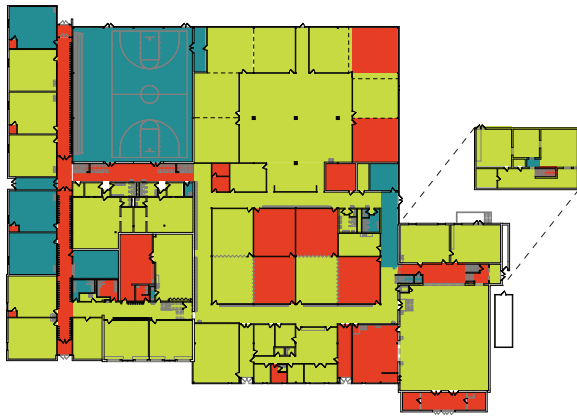
First & Lower Floor

- Materials identified as potentially containing asbestos are considered to be in poor condition.
- Spline ceilings are identified as a potential asbestos containing material.
- There is spline located in the Special Education Classroom on the first floor.
- Majority of the acoustical panel ceilings are in fair condition due to staining and/or cracking. Some acoustical panel ceilings are in poor condition due to excessive staining.

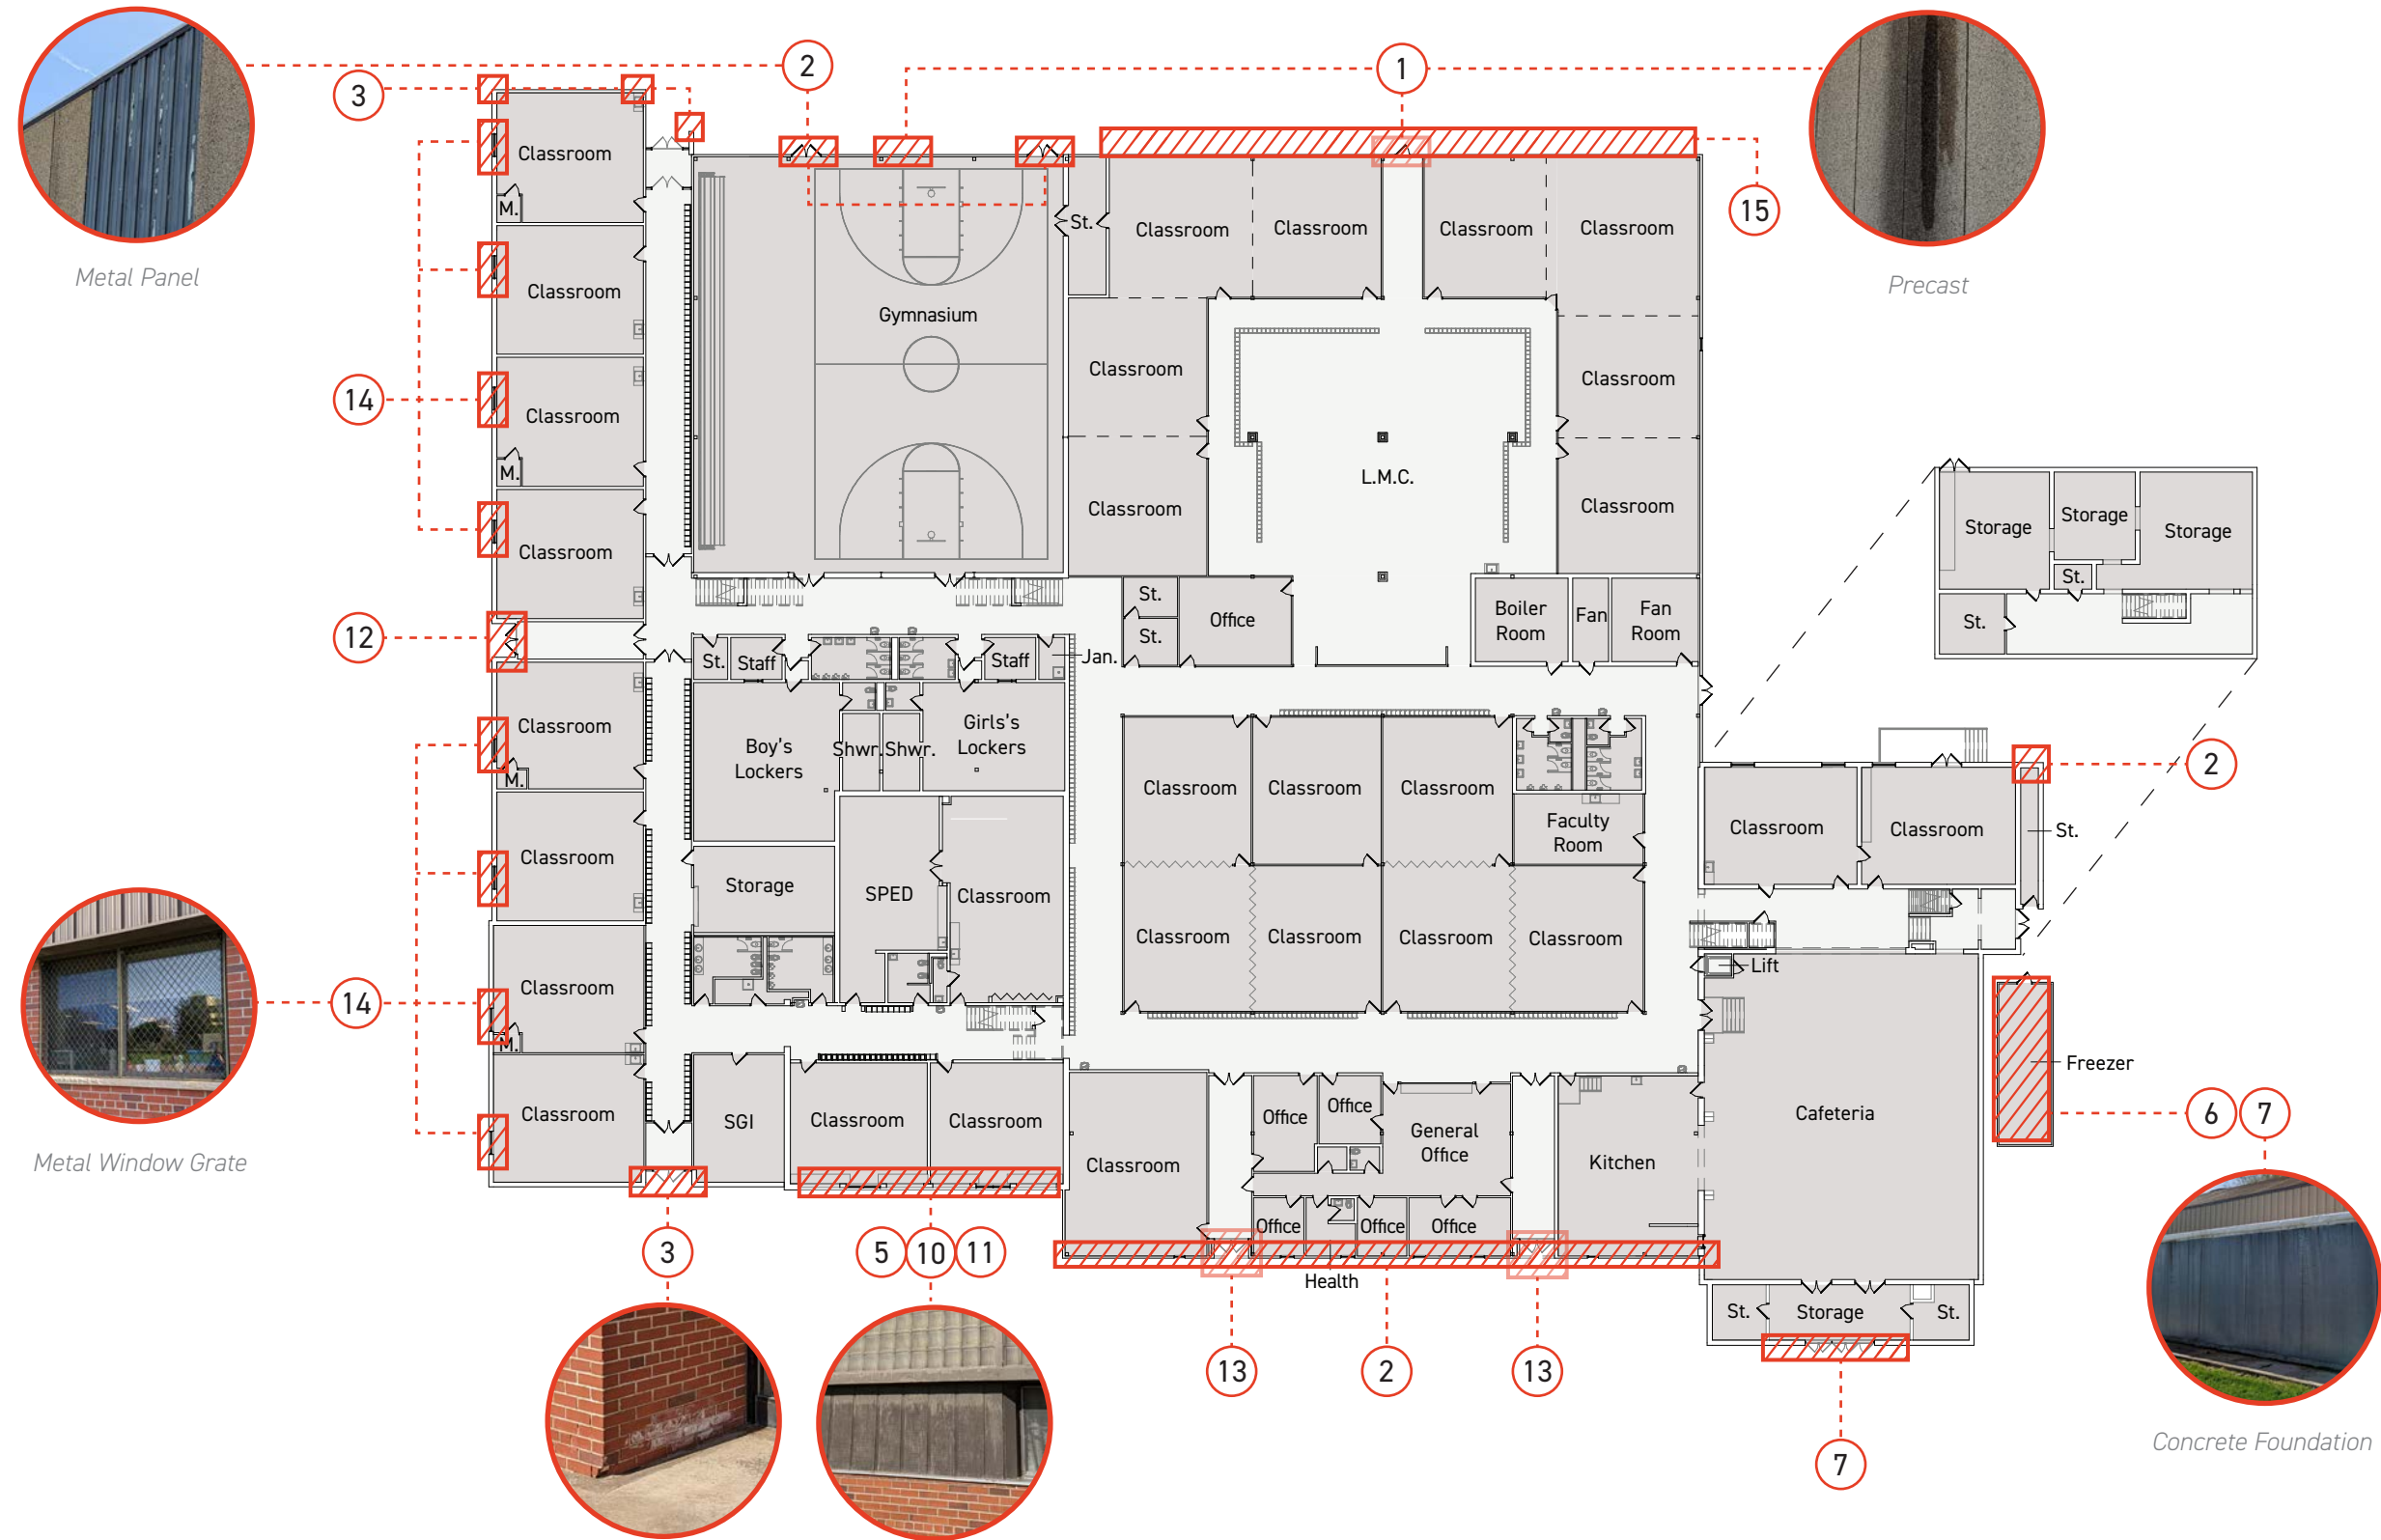
- Majority of the precast is in fair condition with some areas in poor condition due to staining and/or cracking.
- Majority of the brick is in fair condition. Some areas in poor condition due to cracking and/or crumbling.
- Majority of the metal panel is in fair condition due to peeling paint.
- Majority of caulking at wall joints is in poor condition due to deterioration.
- Some instances where the wood siding is in poor condition due to surface weathering.
- Metal grates on windows are in poor condition due to rusting.

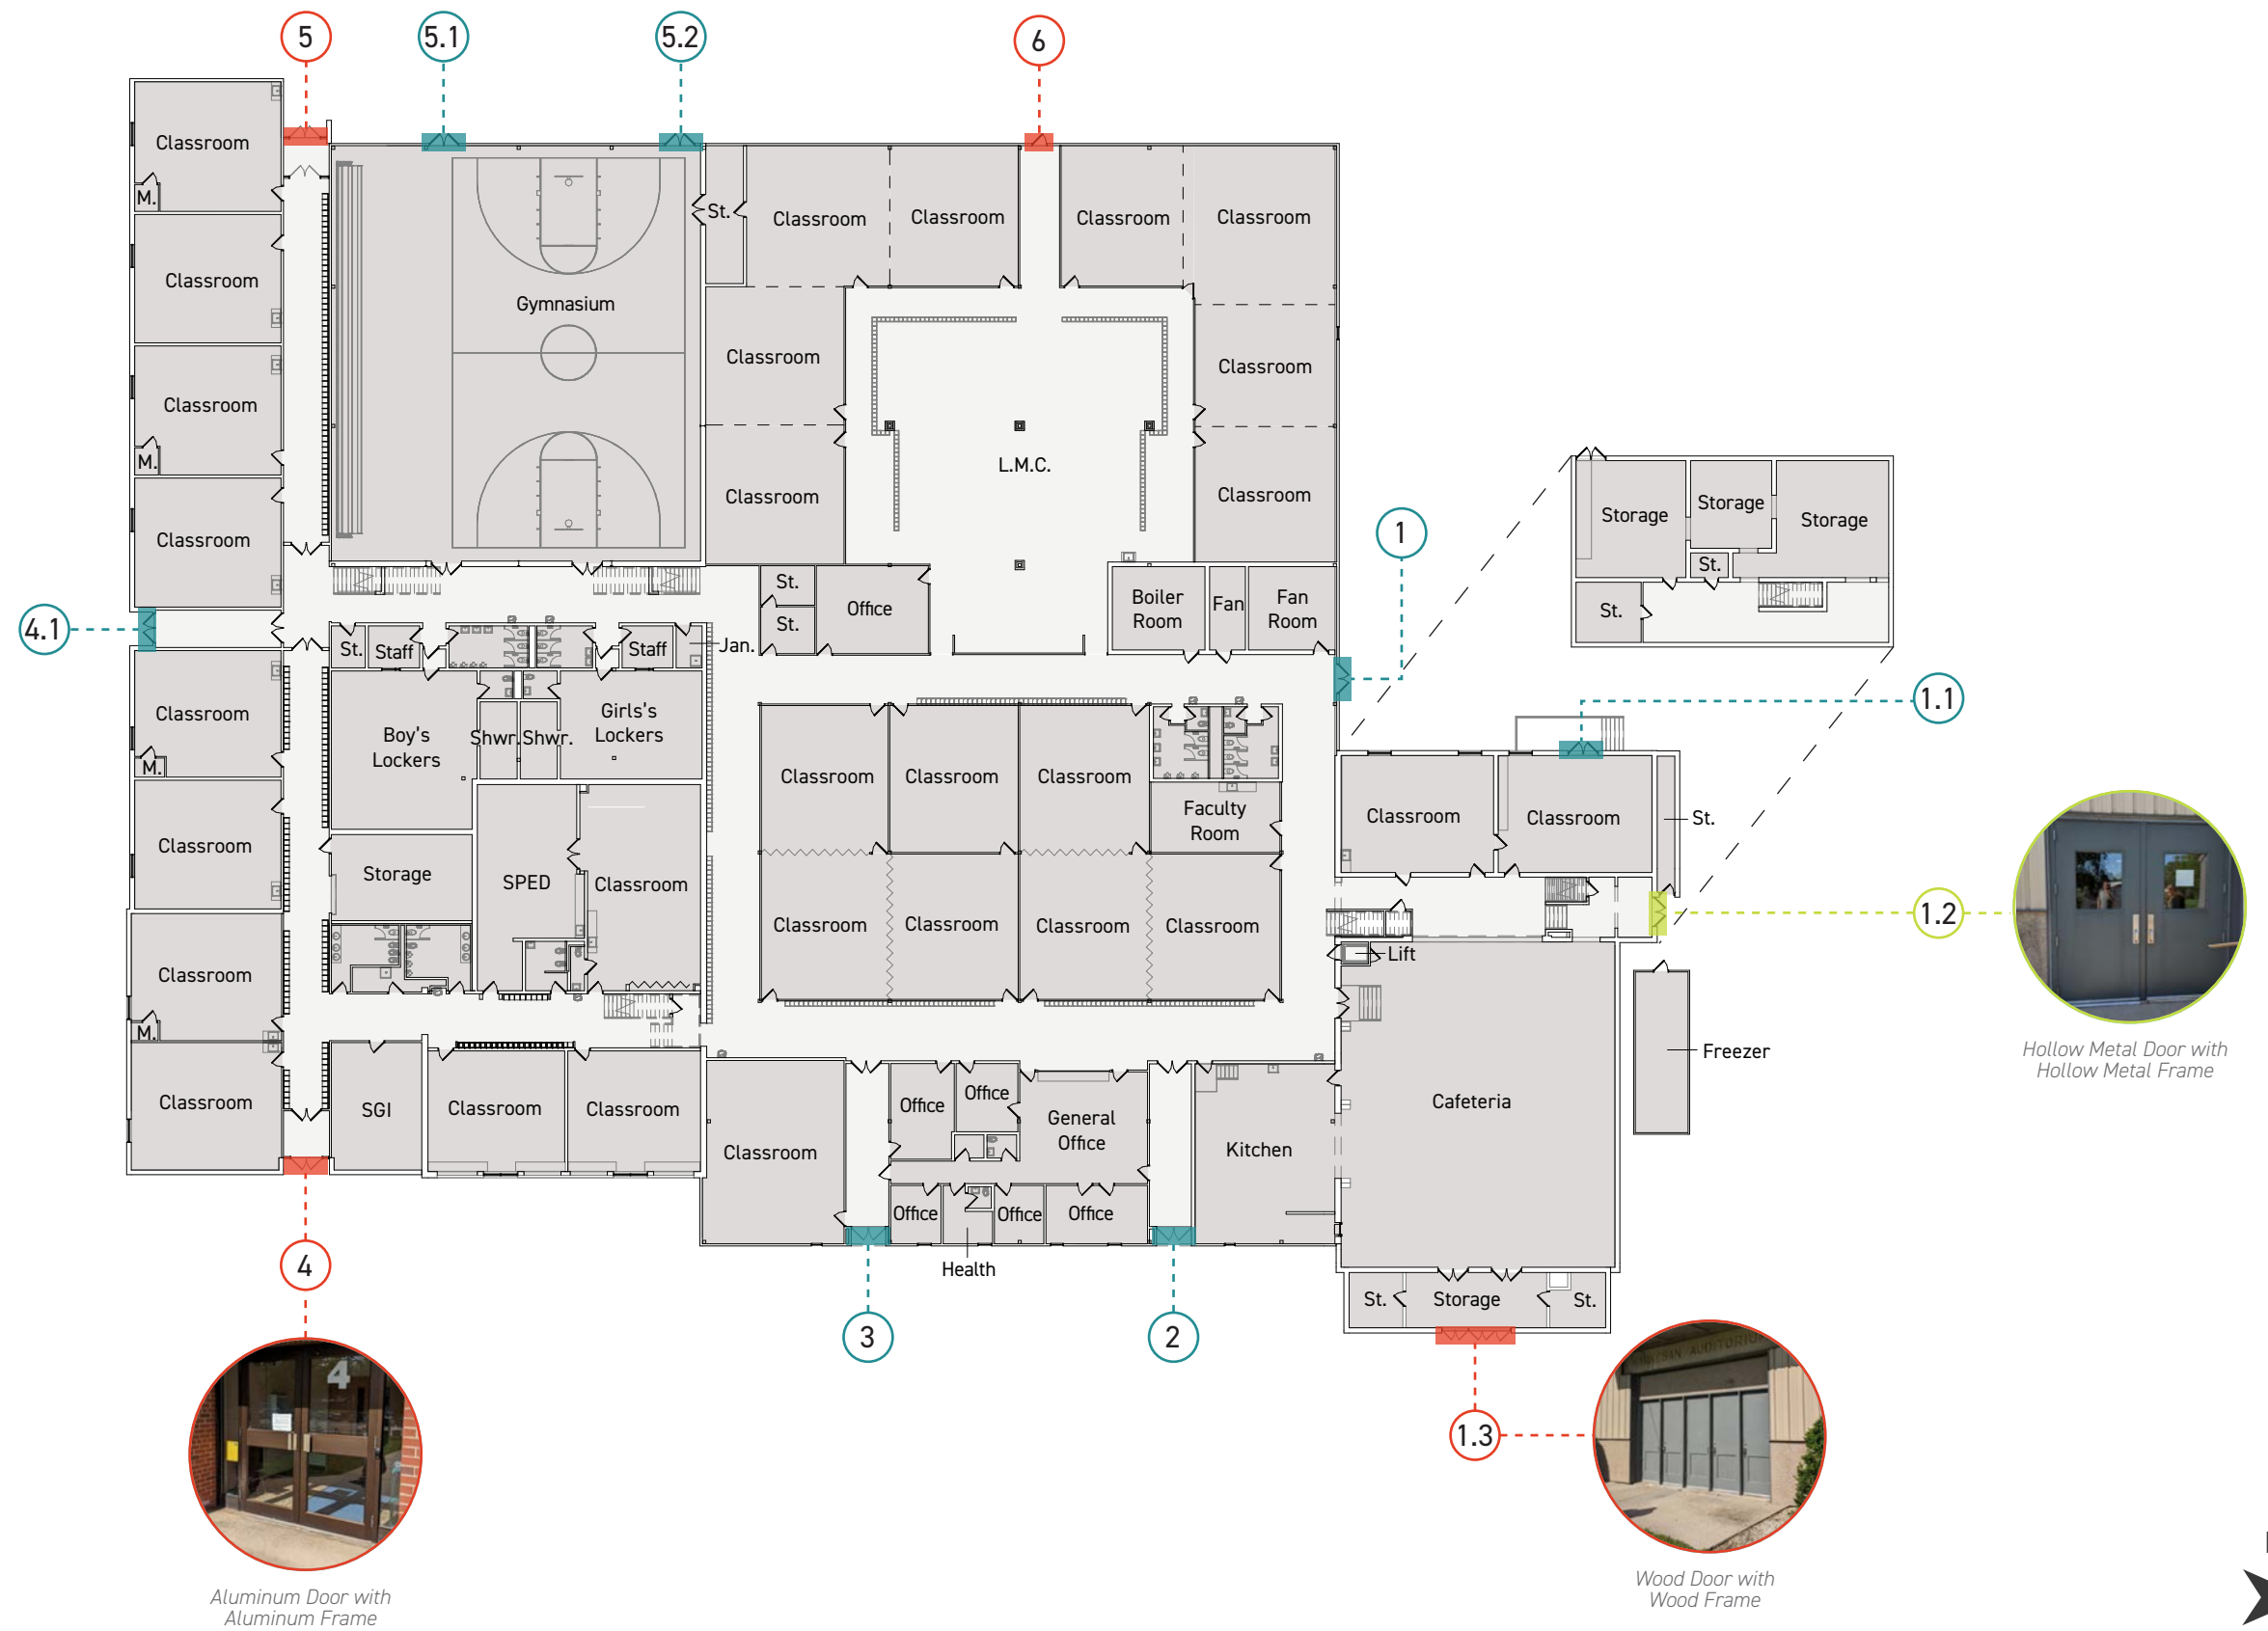
- Majority of the aluminum doors and frames are in good condition.
- Several instances where hollow metal doors are in poor condition due to rusting, weathering, surface scratches, paint peeling off and/or surface bubbling.
- Wood doors are in poor condition due to weathering, surface cracking, and paint peeling off.

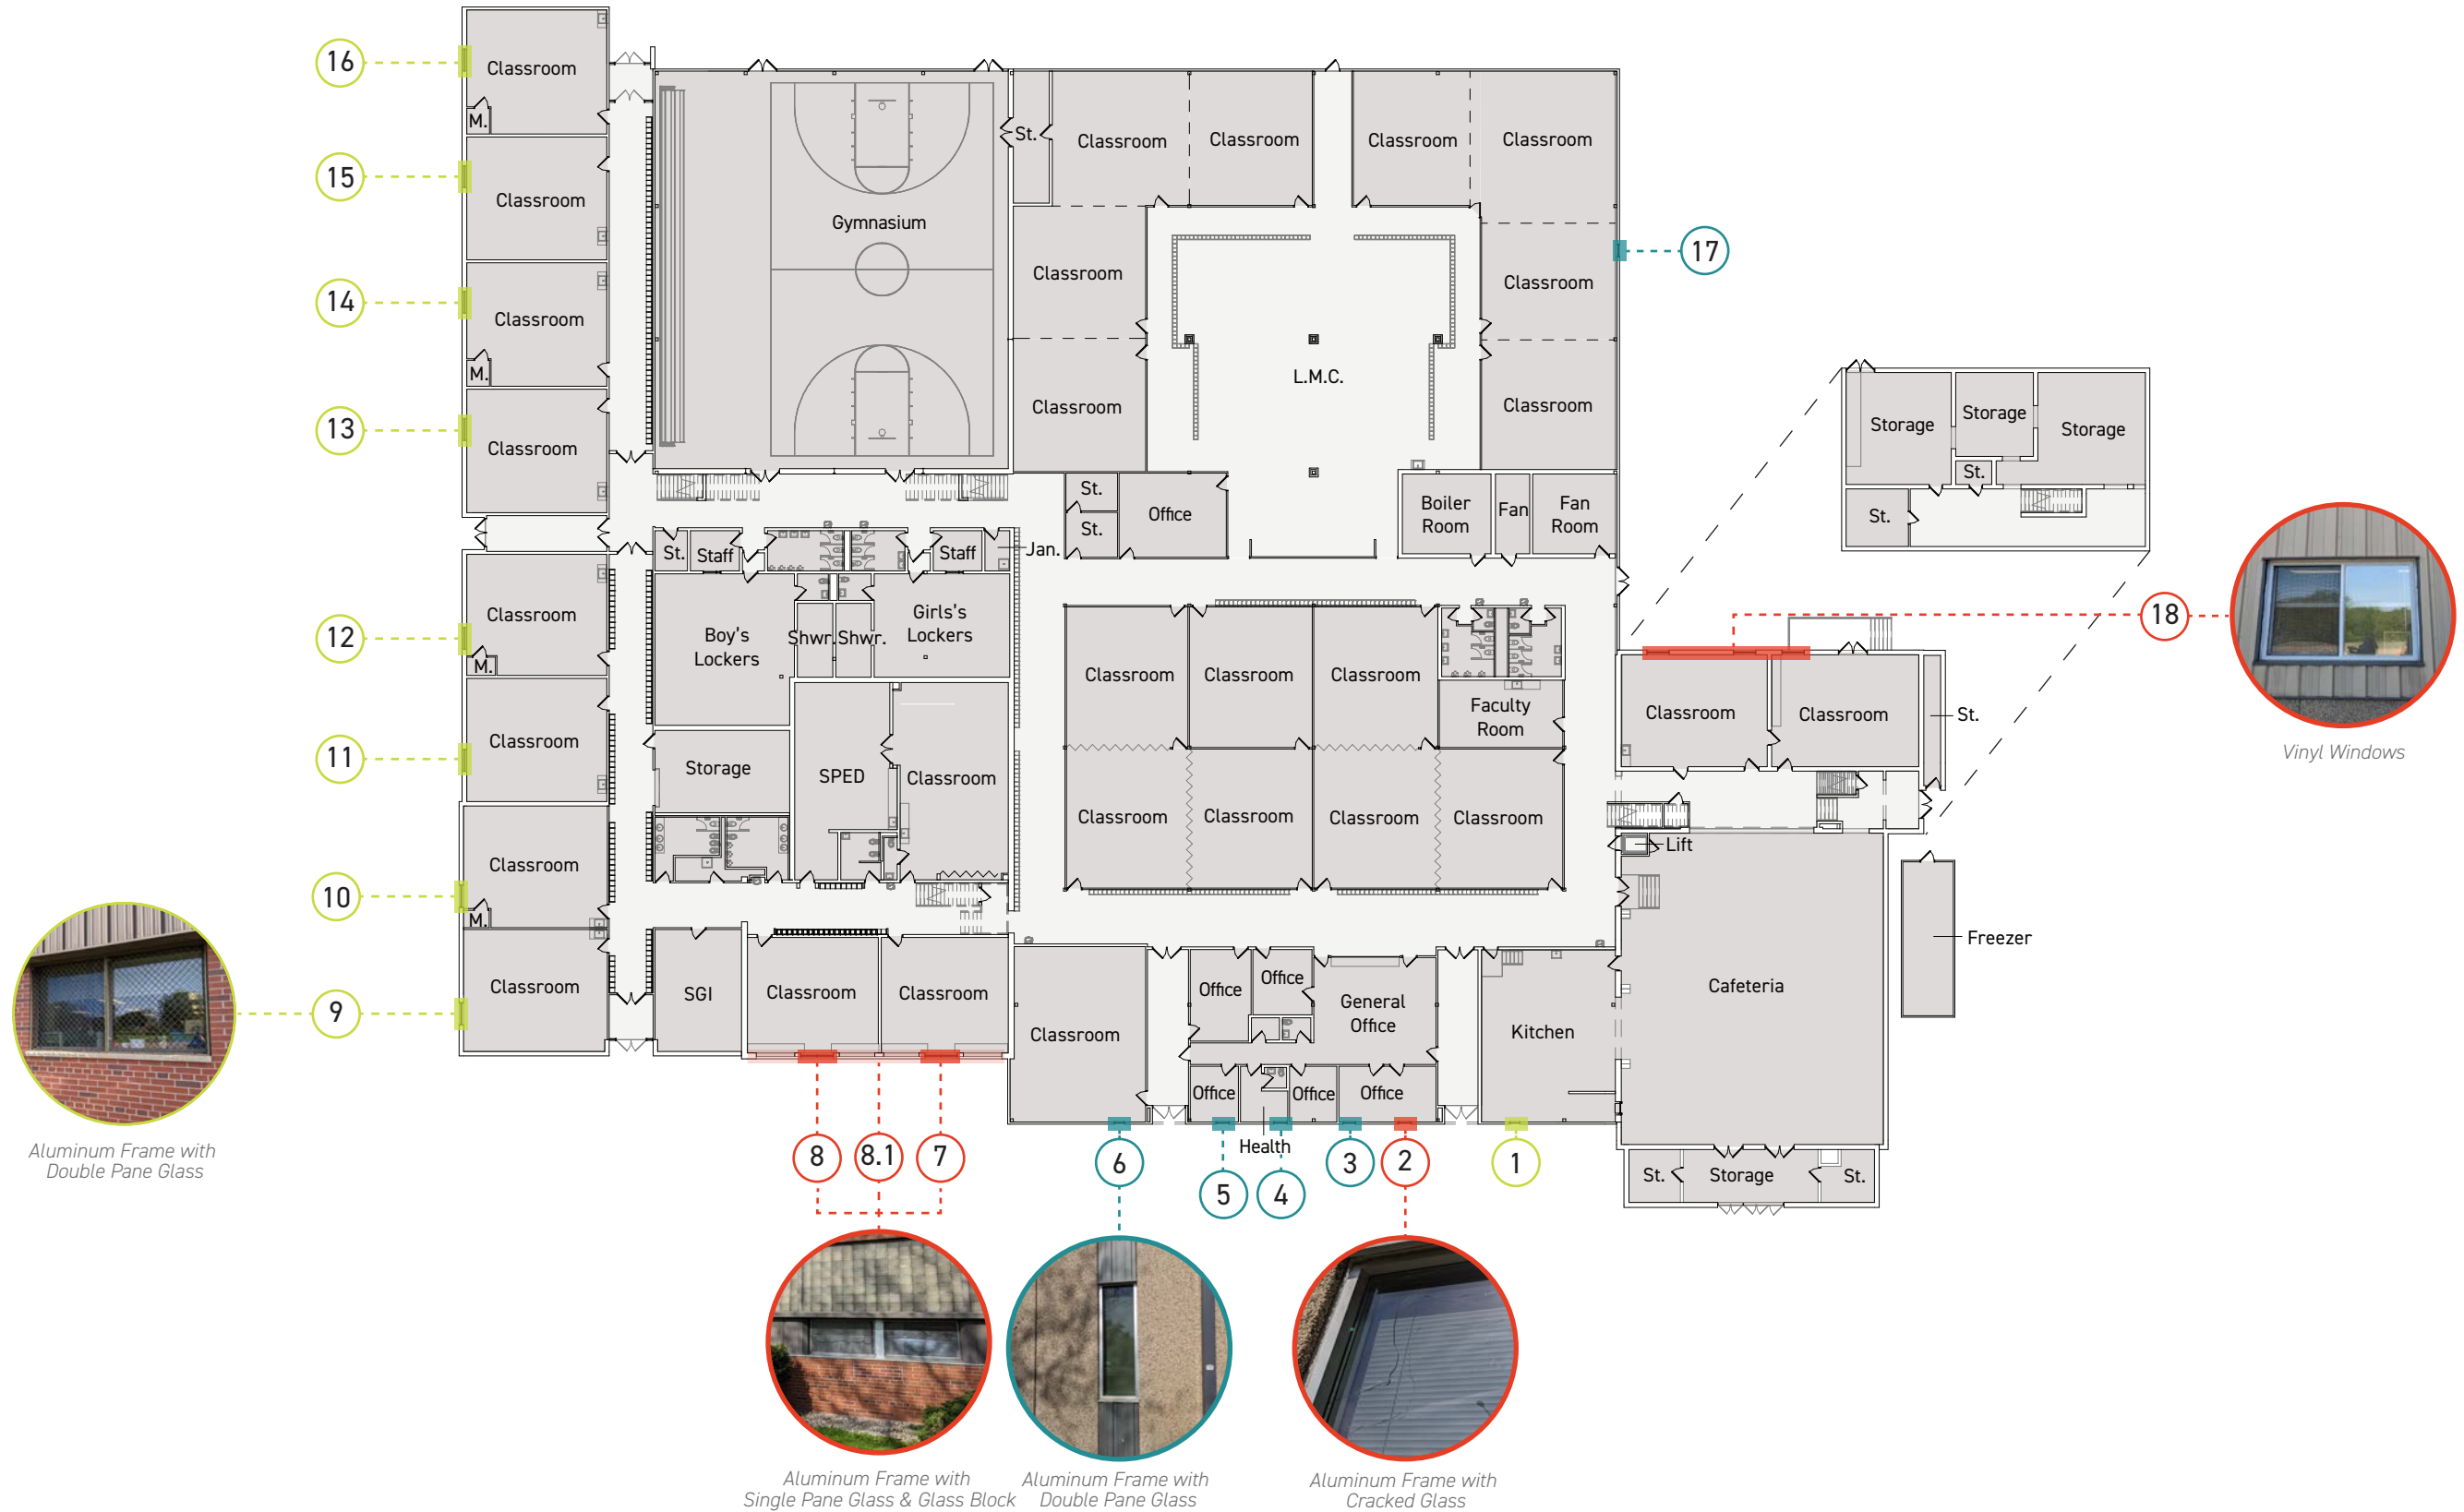
- Majority of the aluminum framed windows with double pane glass are in good condition.
- Majority of the vinyl windows are in poor condition due to weathering.
- Window #2 is in poor condition due to a crack in the glass.

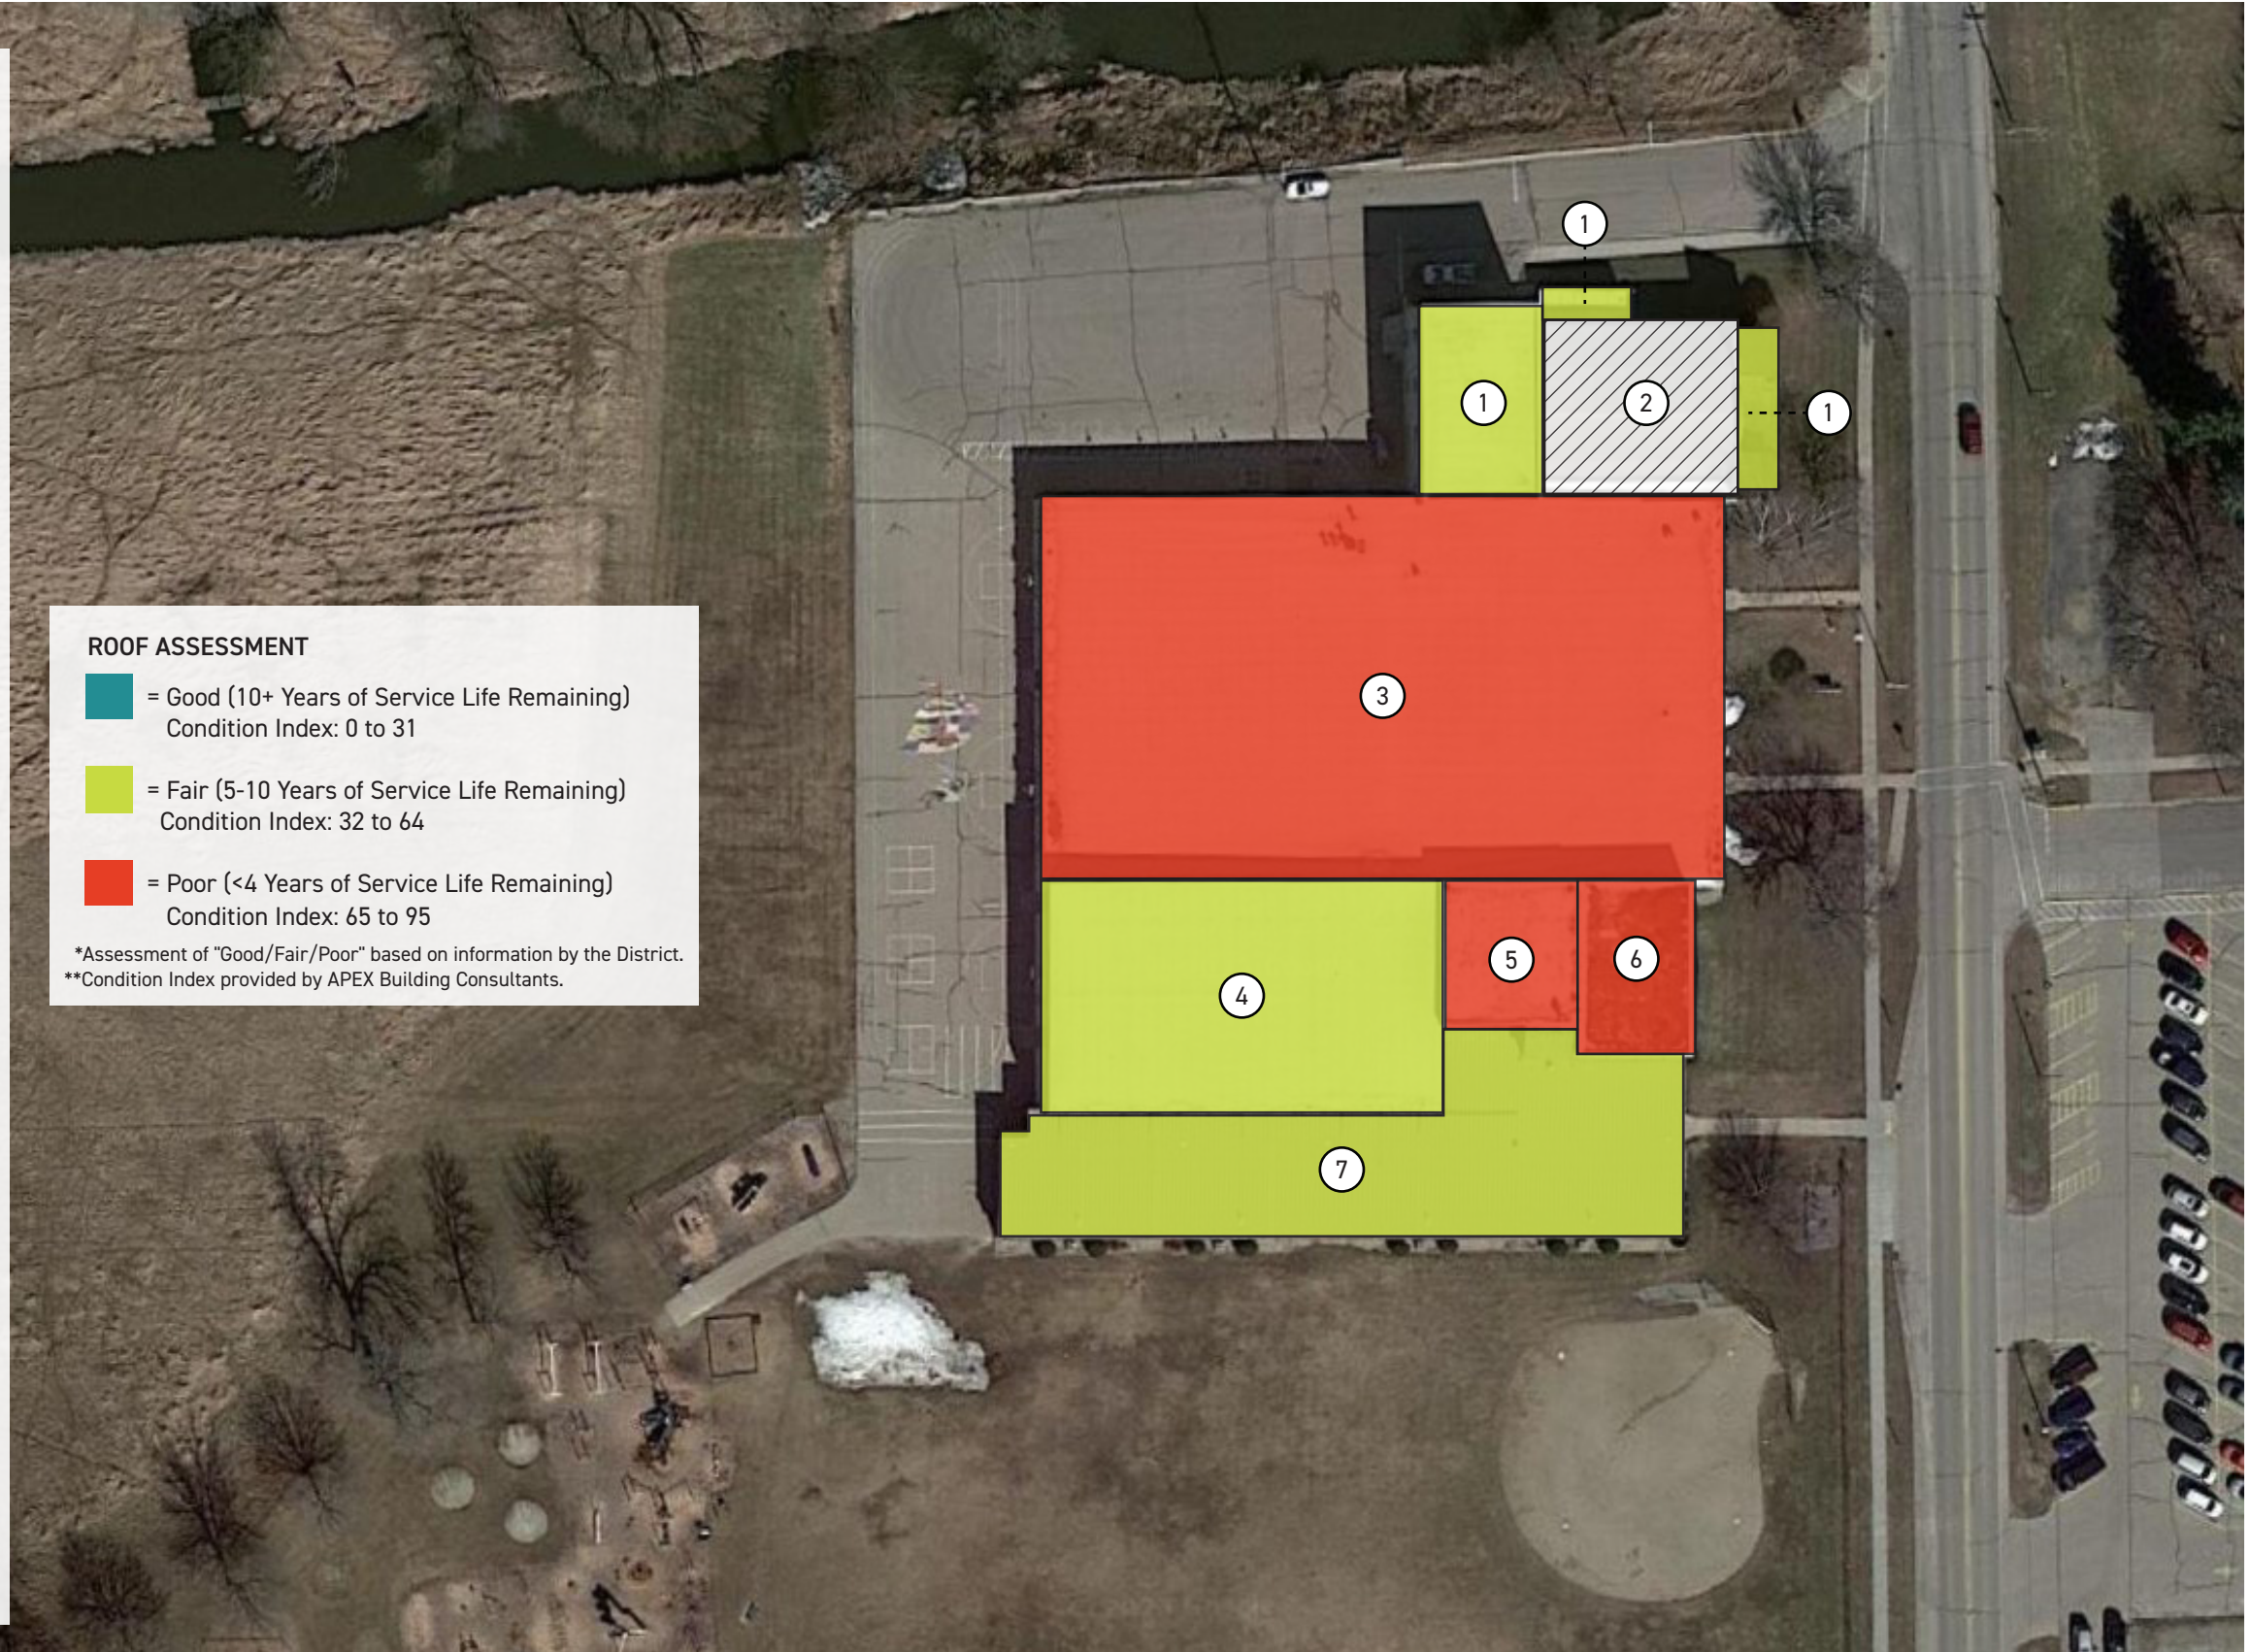
ROOF AREAS

- ① = 2006 Installation, Condition Index: 56
- ② = Unknown Installation, Condition Index: Unknown
- ③ = 2008 Installation, Condition Index: 66
- ④ = 2012 Installation, Condition Index: 47
- ⑤ = 2006 Installation, Condition Index: 81
- ⑥ = 2006 Installation, Condition Index: 85
- ⑦ = 1990 Installation, Condition Index: Unknown

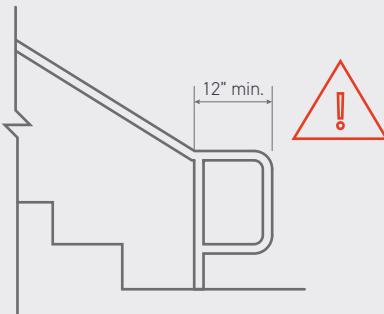
Most Concerning Item That Does Not Meet Code Requirements:

*Not providing ADA compliant railings at stairs*
