Markesan District Schools

District-wide Facilities Study

STUDY DOCUMENT

July 2023

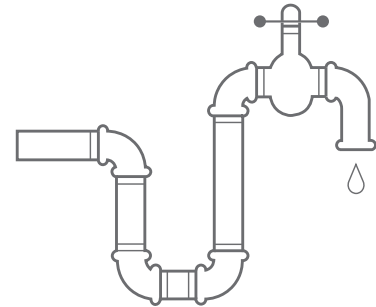
Domestic Water System	■	
Water Service	●	4" water service w/ 3" water meter.
Water Distribution Piping	●	Copper piping. The original piping appears to be in fair condition, but is reaching the end of its life expectancy.
Water Softening System	●	Hot water only.
Backflow Preventer	<input type="radio"/>	
Irrigation System	<input type="radio"/>	
Pressure	●	Adequate
Fire Sprinkler System	<input type="radio"/>	
Sanitary System	■	
Sanitary Sewer	<input type="radio"/>	No issues with the system were reported.
Sanitary Drain, Waste + Vent Piping	<input type="radio"/>	No issues with the system were reported.
Acid Waste Piping + Basin	<input type="radio"/>	
Interceptors	●	No issues with the system were reported.
Storm System	<input type="checkbox"/>	
Storm Sewer	<input type="radio"/>	
Storm Drain Piping	<input type="radio"/>	
Roof Drainage	<input type="radio"/>	
Sump Pump	<input type="radio"/>	
Natural Gas System	■	No issues with the system were reported.

Replace all piping with new copper piping

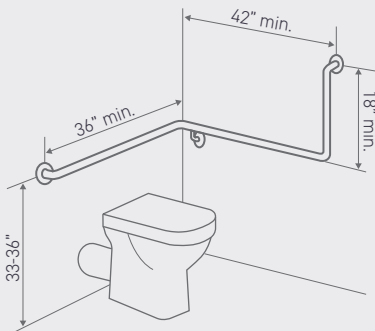
Not providing at proper grab bars at ADA accessible toilet.
