# Focus Group

Facility Study & Master Planning Services  
Markesan District Schools

September 20, 2023

District-wide Facilities Study

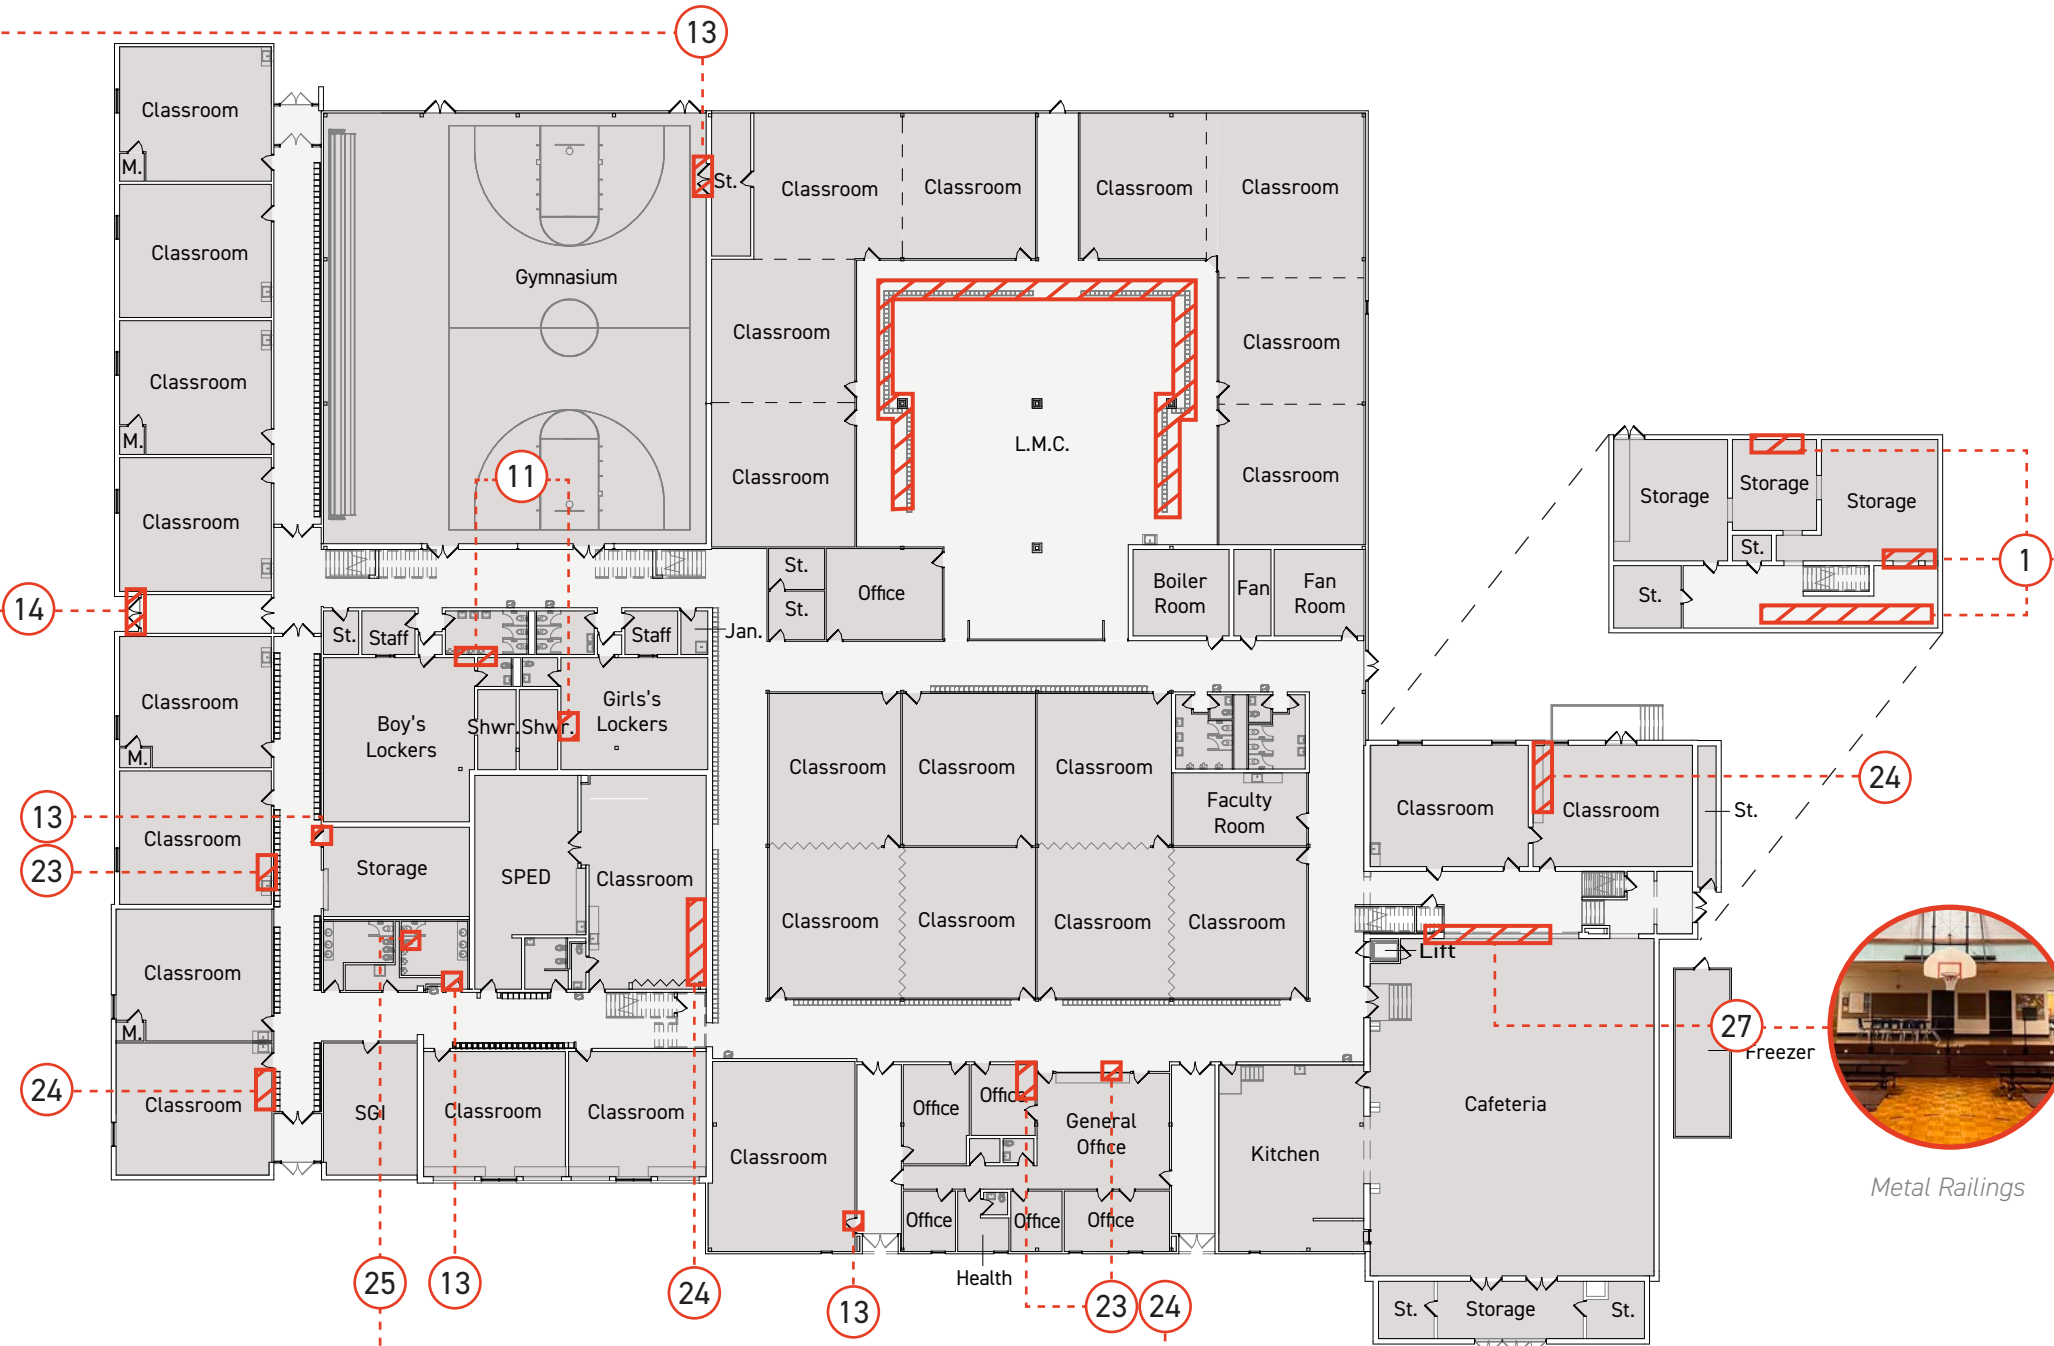
- Majority of the aluminum doors with aluminum frames are in good condition. Some doors in fair condition due to staining and/or surface scratches.
- Majority of the wood doors with hollow metal frames are in good condition. Some doors in fair condition due to staining and/or surface scratches.
- Majority of the concrete block walls are in good condition. There are some areas in poor condition due to cracking, splitting, broken and/or missing blocks.
- There are several instances where the tile wall base is in poor condition due to chipping, cracking, and/or missing tiles.
- The railing at the stage of the cafeteria currently consists of vertical metal posts with rope barriers between, posing a potential safety/code issue.
- Some doors contain transfer grilles.

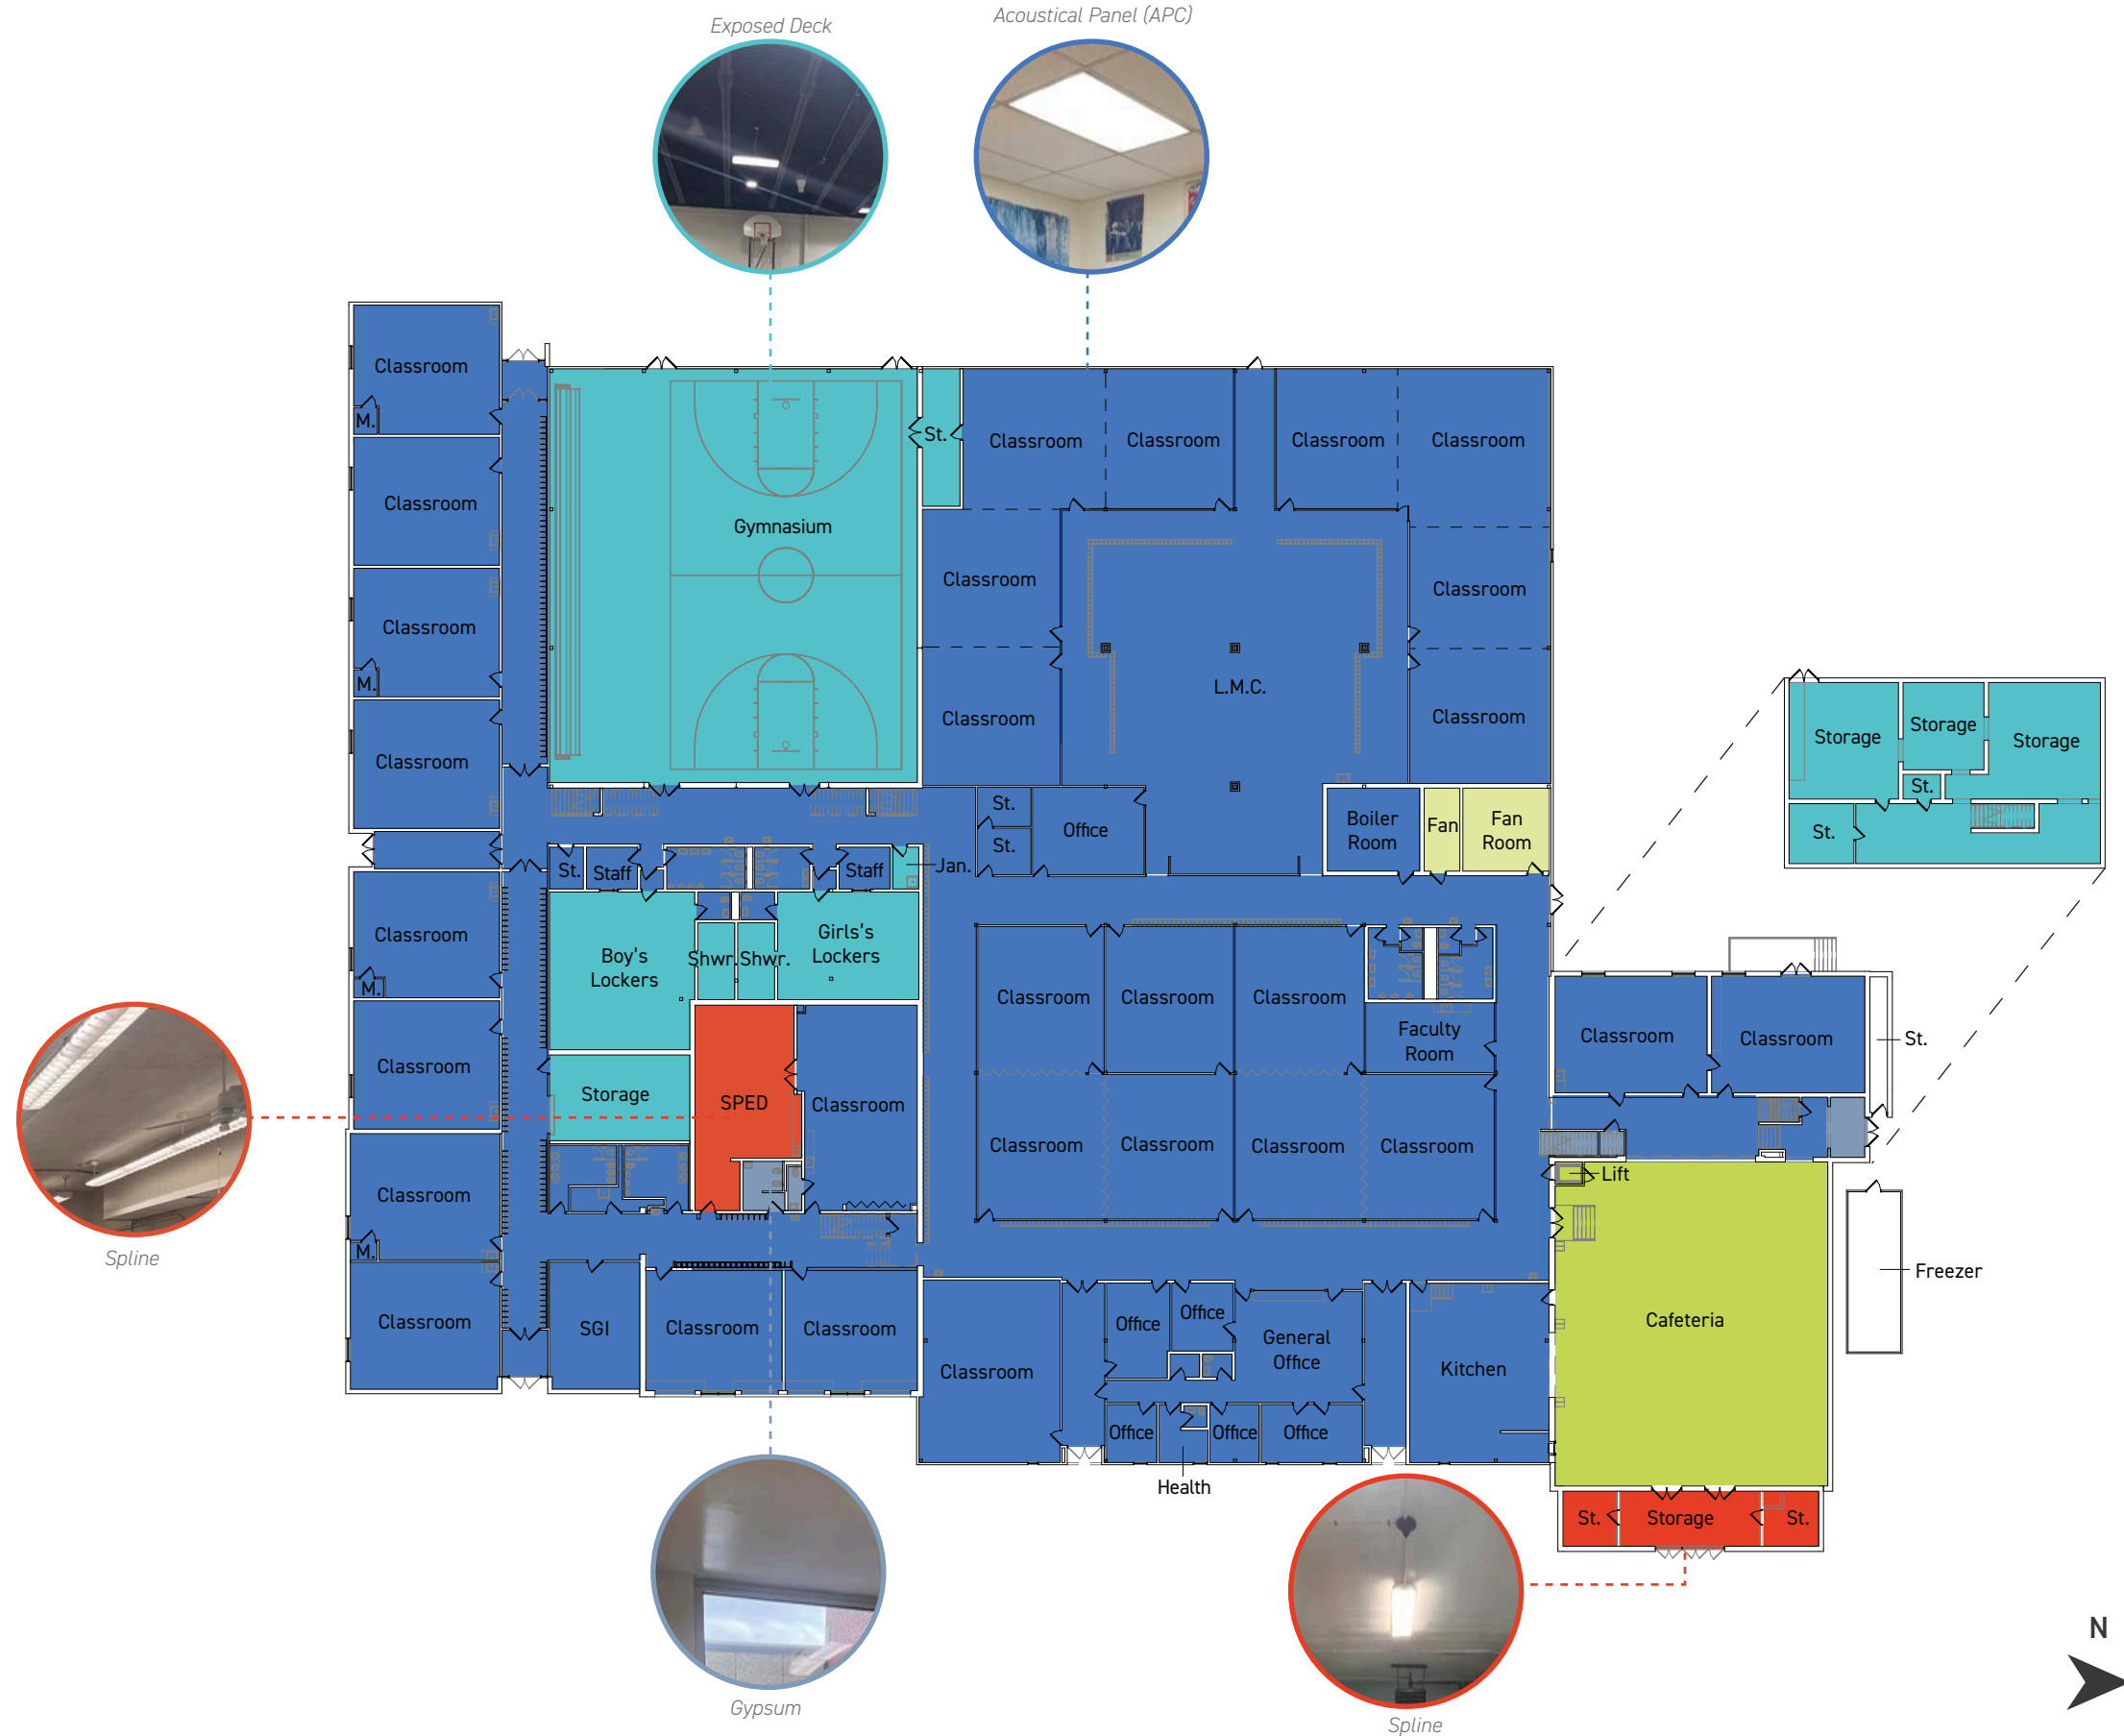
- Materials identified as potentially containing asbestos are considered to be in poor condition.
- Spline ceilings are identified as a potential asbestos containing material.
- There is spline located in the Special Education Classroom on the first floor.
- Majority of the acoustical panel ceilings are in fair condition due to staining and/or cracking. Some acoustical panel ceilings are in poor condition due to excessive staining.

Asbestos is a material that was used in the construction industry, most commonly between 1960 - 1990. **There was no asbestos testing performed for this assessment.** Observations and assumptions were made based on common older building materials that typically have been identified to containing asbestos.

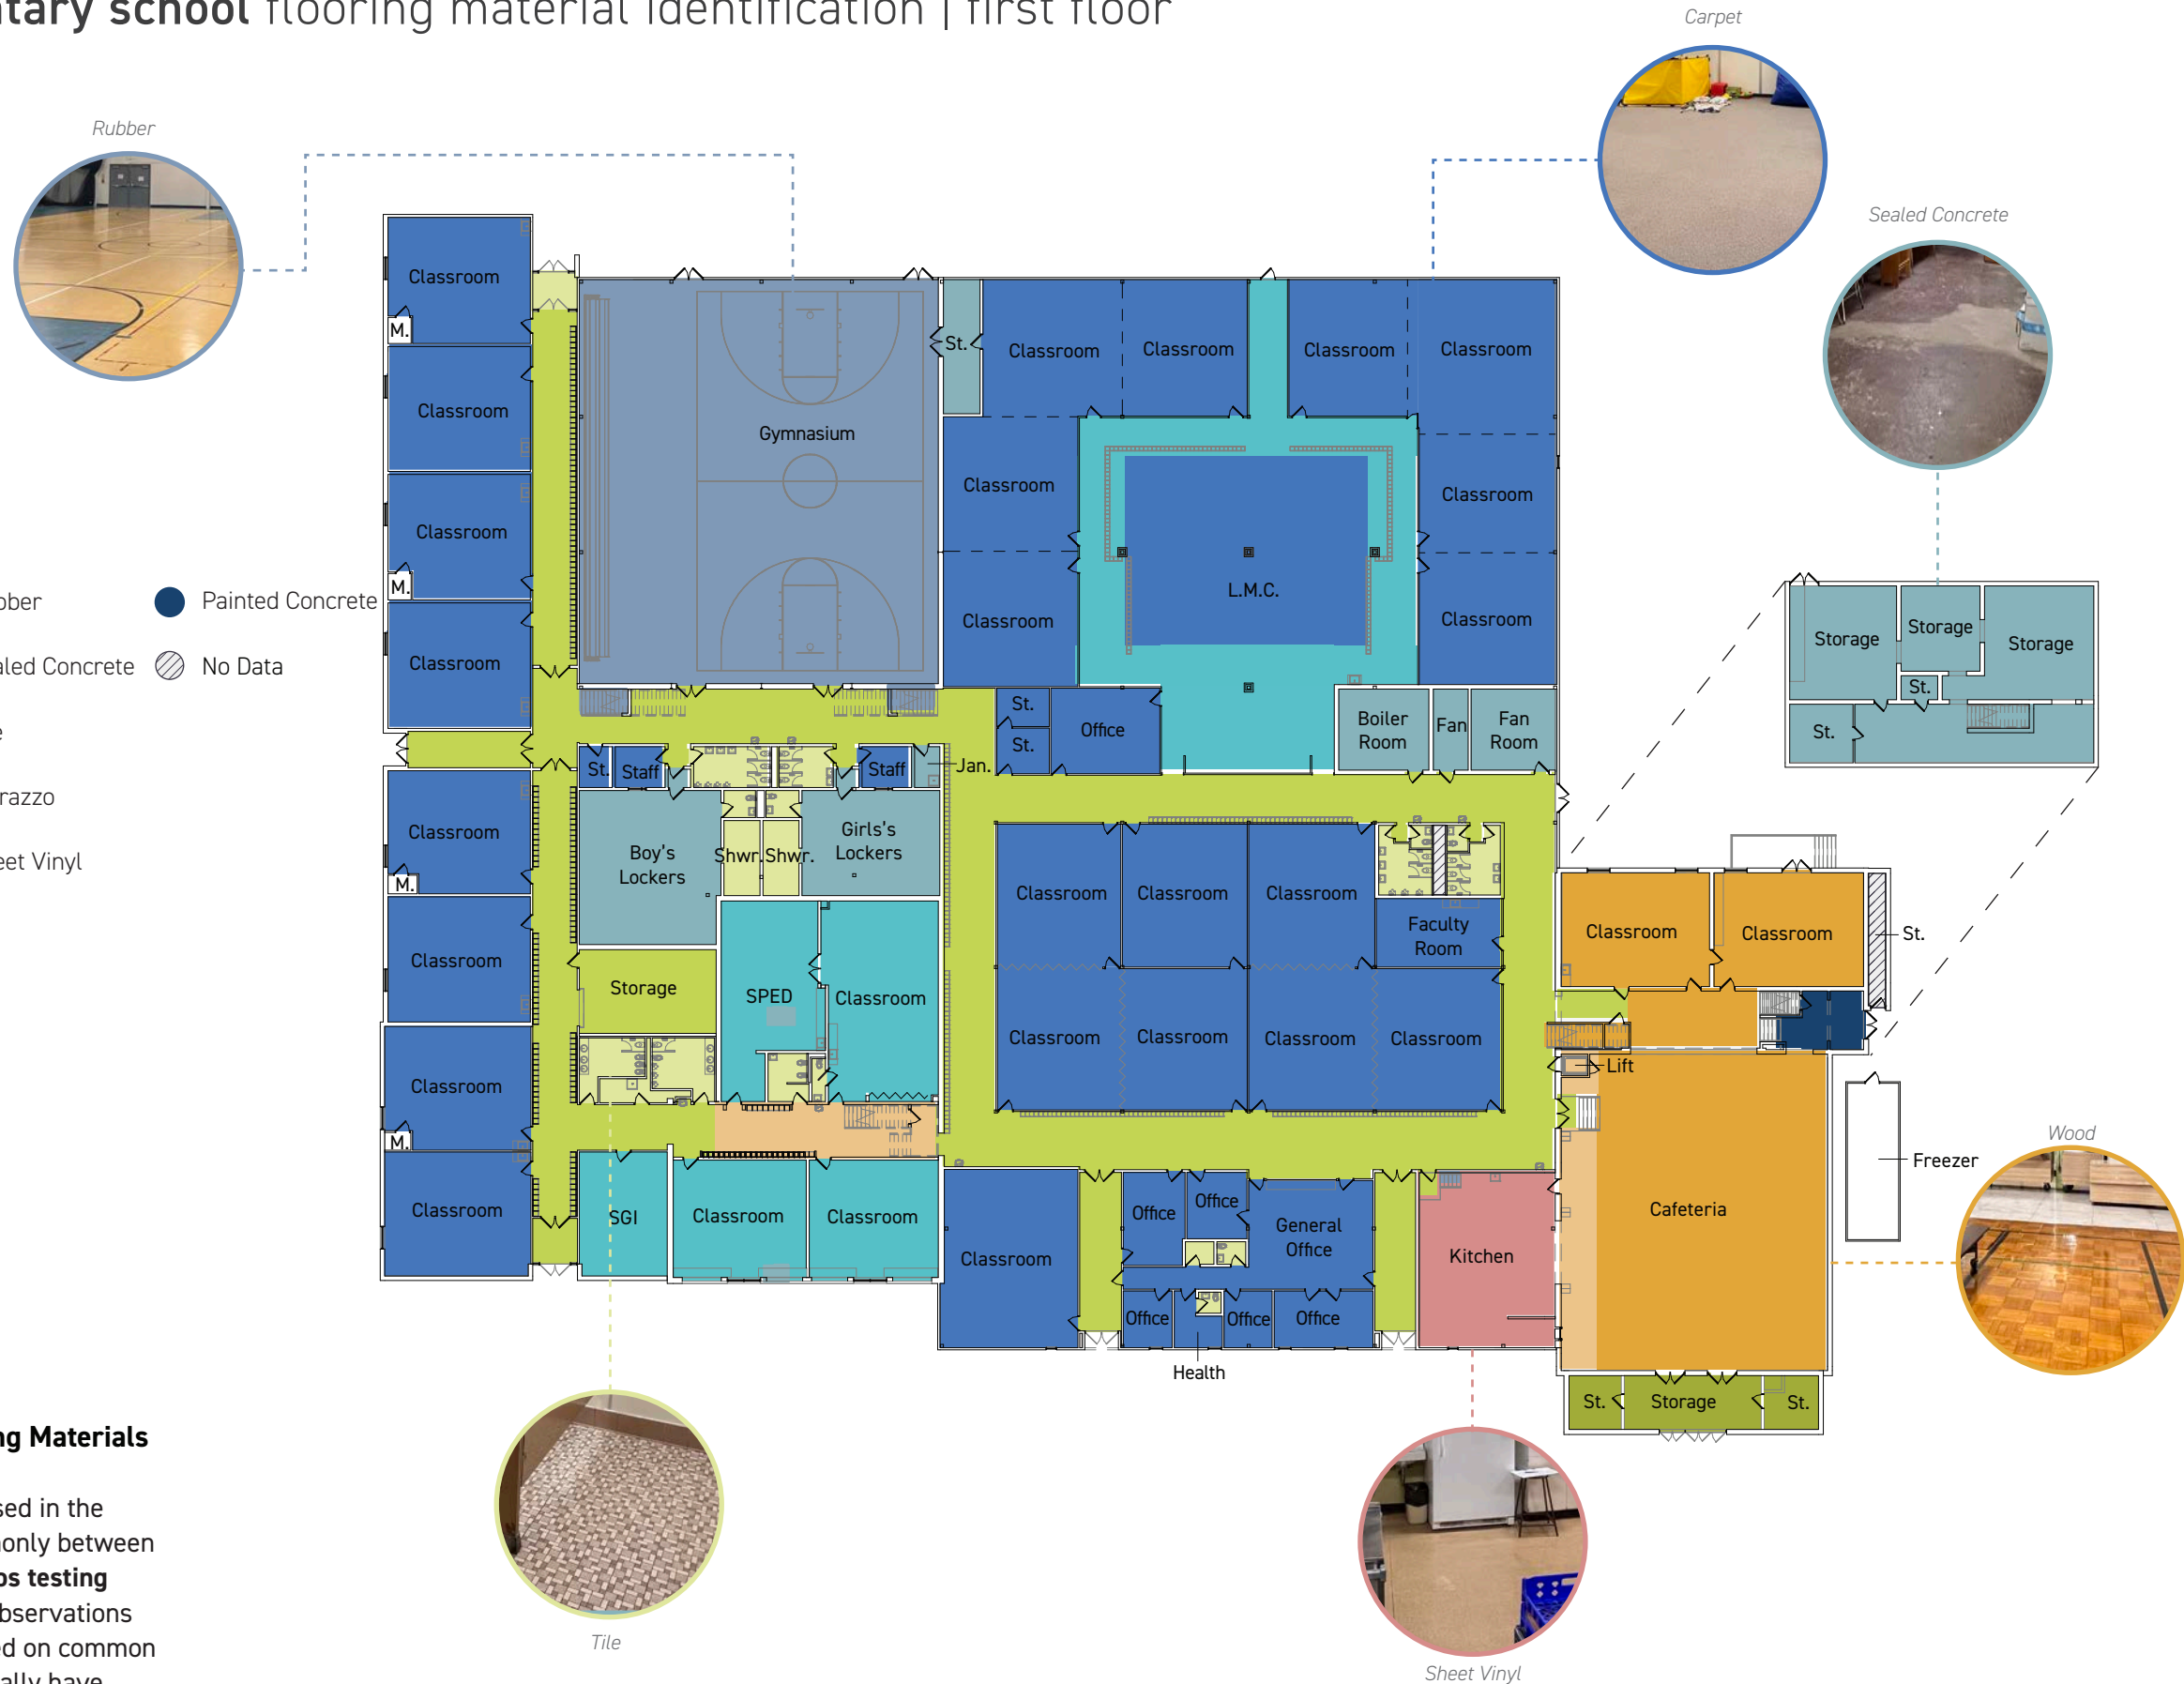
# markesan elementary school flooring analysis

- Materials identified as potentially containing asbestos are considered to be in poor condition.
- 9" x 9" vinyl tile flooring is identified as potential asbestos tile.
- There are some areas where the wood flooring is in poor condition due to cracking, chipping, and/or surface scratches.
- There are some areas where the concrete flooring is in poor condition due to cracking, chipping, and/or surface scratches.
- There are some areas where the floor tile is in poor condition due to surface cracking and/or splitting tiles.

Asbestos is a material that was used in the construction industry, most commonly between 1960 - 1990. **There was no asbestos testing performed for this assessment.** Observations and assumptions were made based on common older building materials that typically have been identified to containing asbestos.

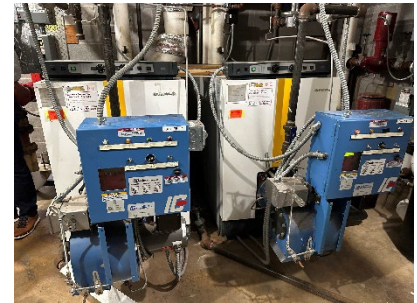
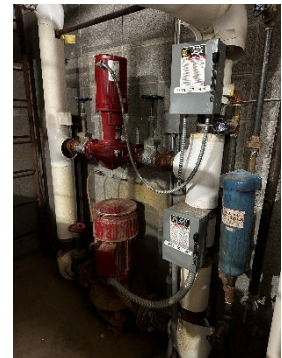
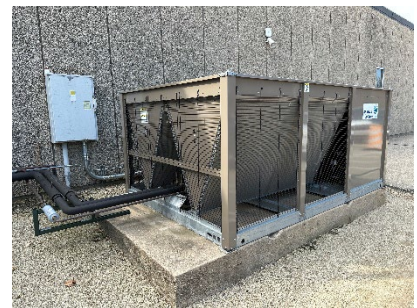
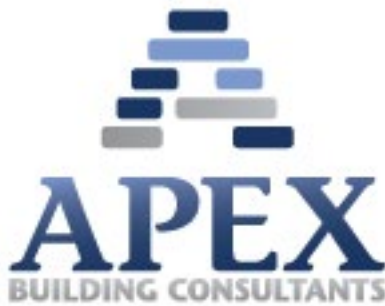
1. The boilers are believed to have been installed between 2010 and 2013 although the exact date is not known at this time. They appear to be in good condition. The boilers have all been well maintained. The ASHRAE service life expectancy is 20-25 years.
2. The hot water system pumps appear to be about 25 years old. Their ASHRAE service life expectancy is approximately 20-25 years.
3. The large JCI 50-ton condensing unit was recently installed in 2021. It is in excellent condition. The ASHRAE service life expectancy for this unit is approximately 20-25 years.
