Markesan District Schools

District-wide Facilities Study

STUDY DOCUMENT

July 2023

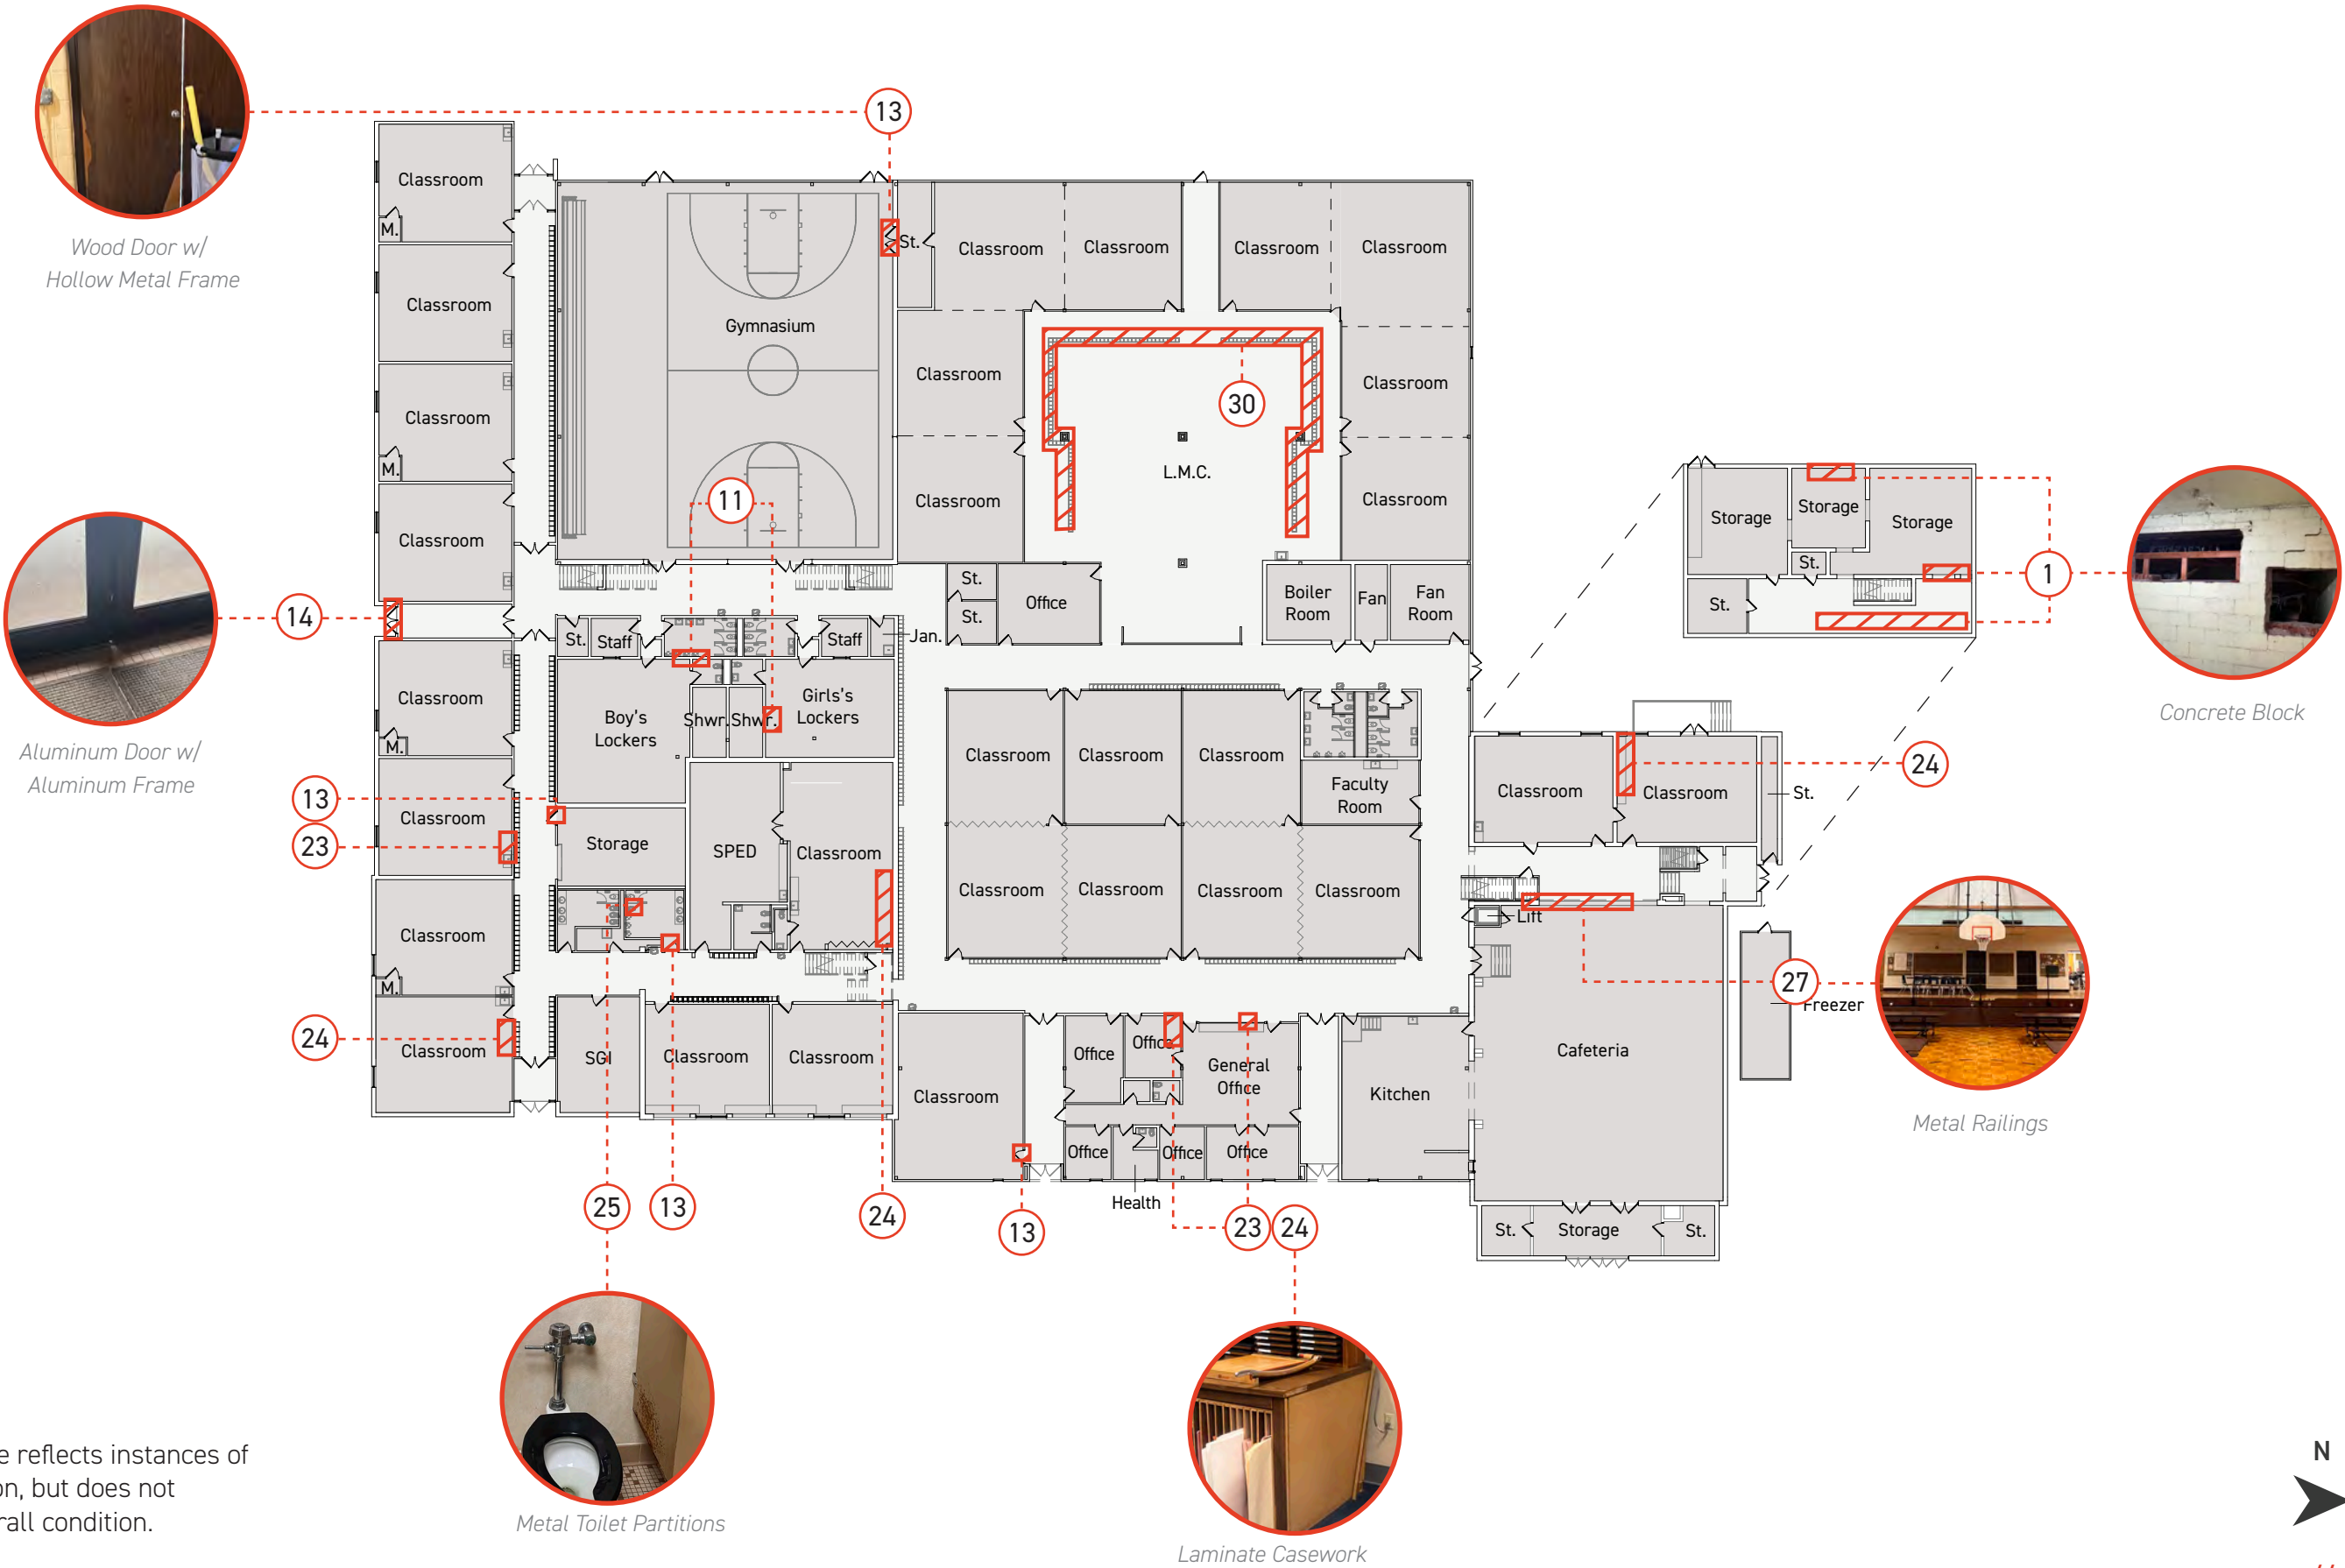
markesan elementary school interior identifications + analysis | first floor

- Majority of the aluminum doors with aluminum frames are in good condition. Some doors in fair condition due to staining and/or surface scratches.
- Majority of the wood doors with hollow metal frames are in good condition. Some doors in fair condition due to staining and/or surface scratches.
- Majority of the concrete block walls are in good condition. There are some areas in poor condition due to cracking, splitting, broken and/or missing blocks.
- There are several instances where the tile wall base is in poor condition due to chipping, cracking, and/or missing tiles.
- The railing at the stage of the cafeteria currently consists of vertical metal posts with rope barriers between, posing a potential safety/code issue.
- Some doors contain transfer grilles.

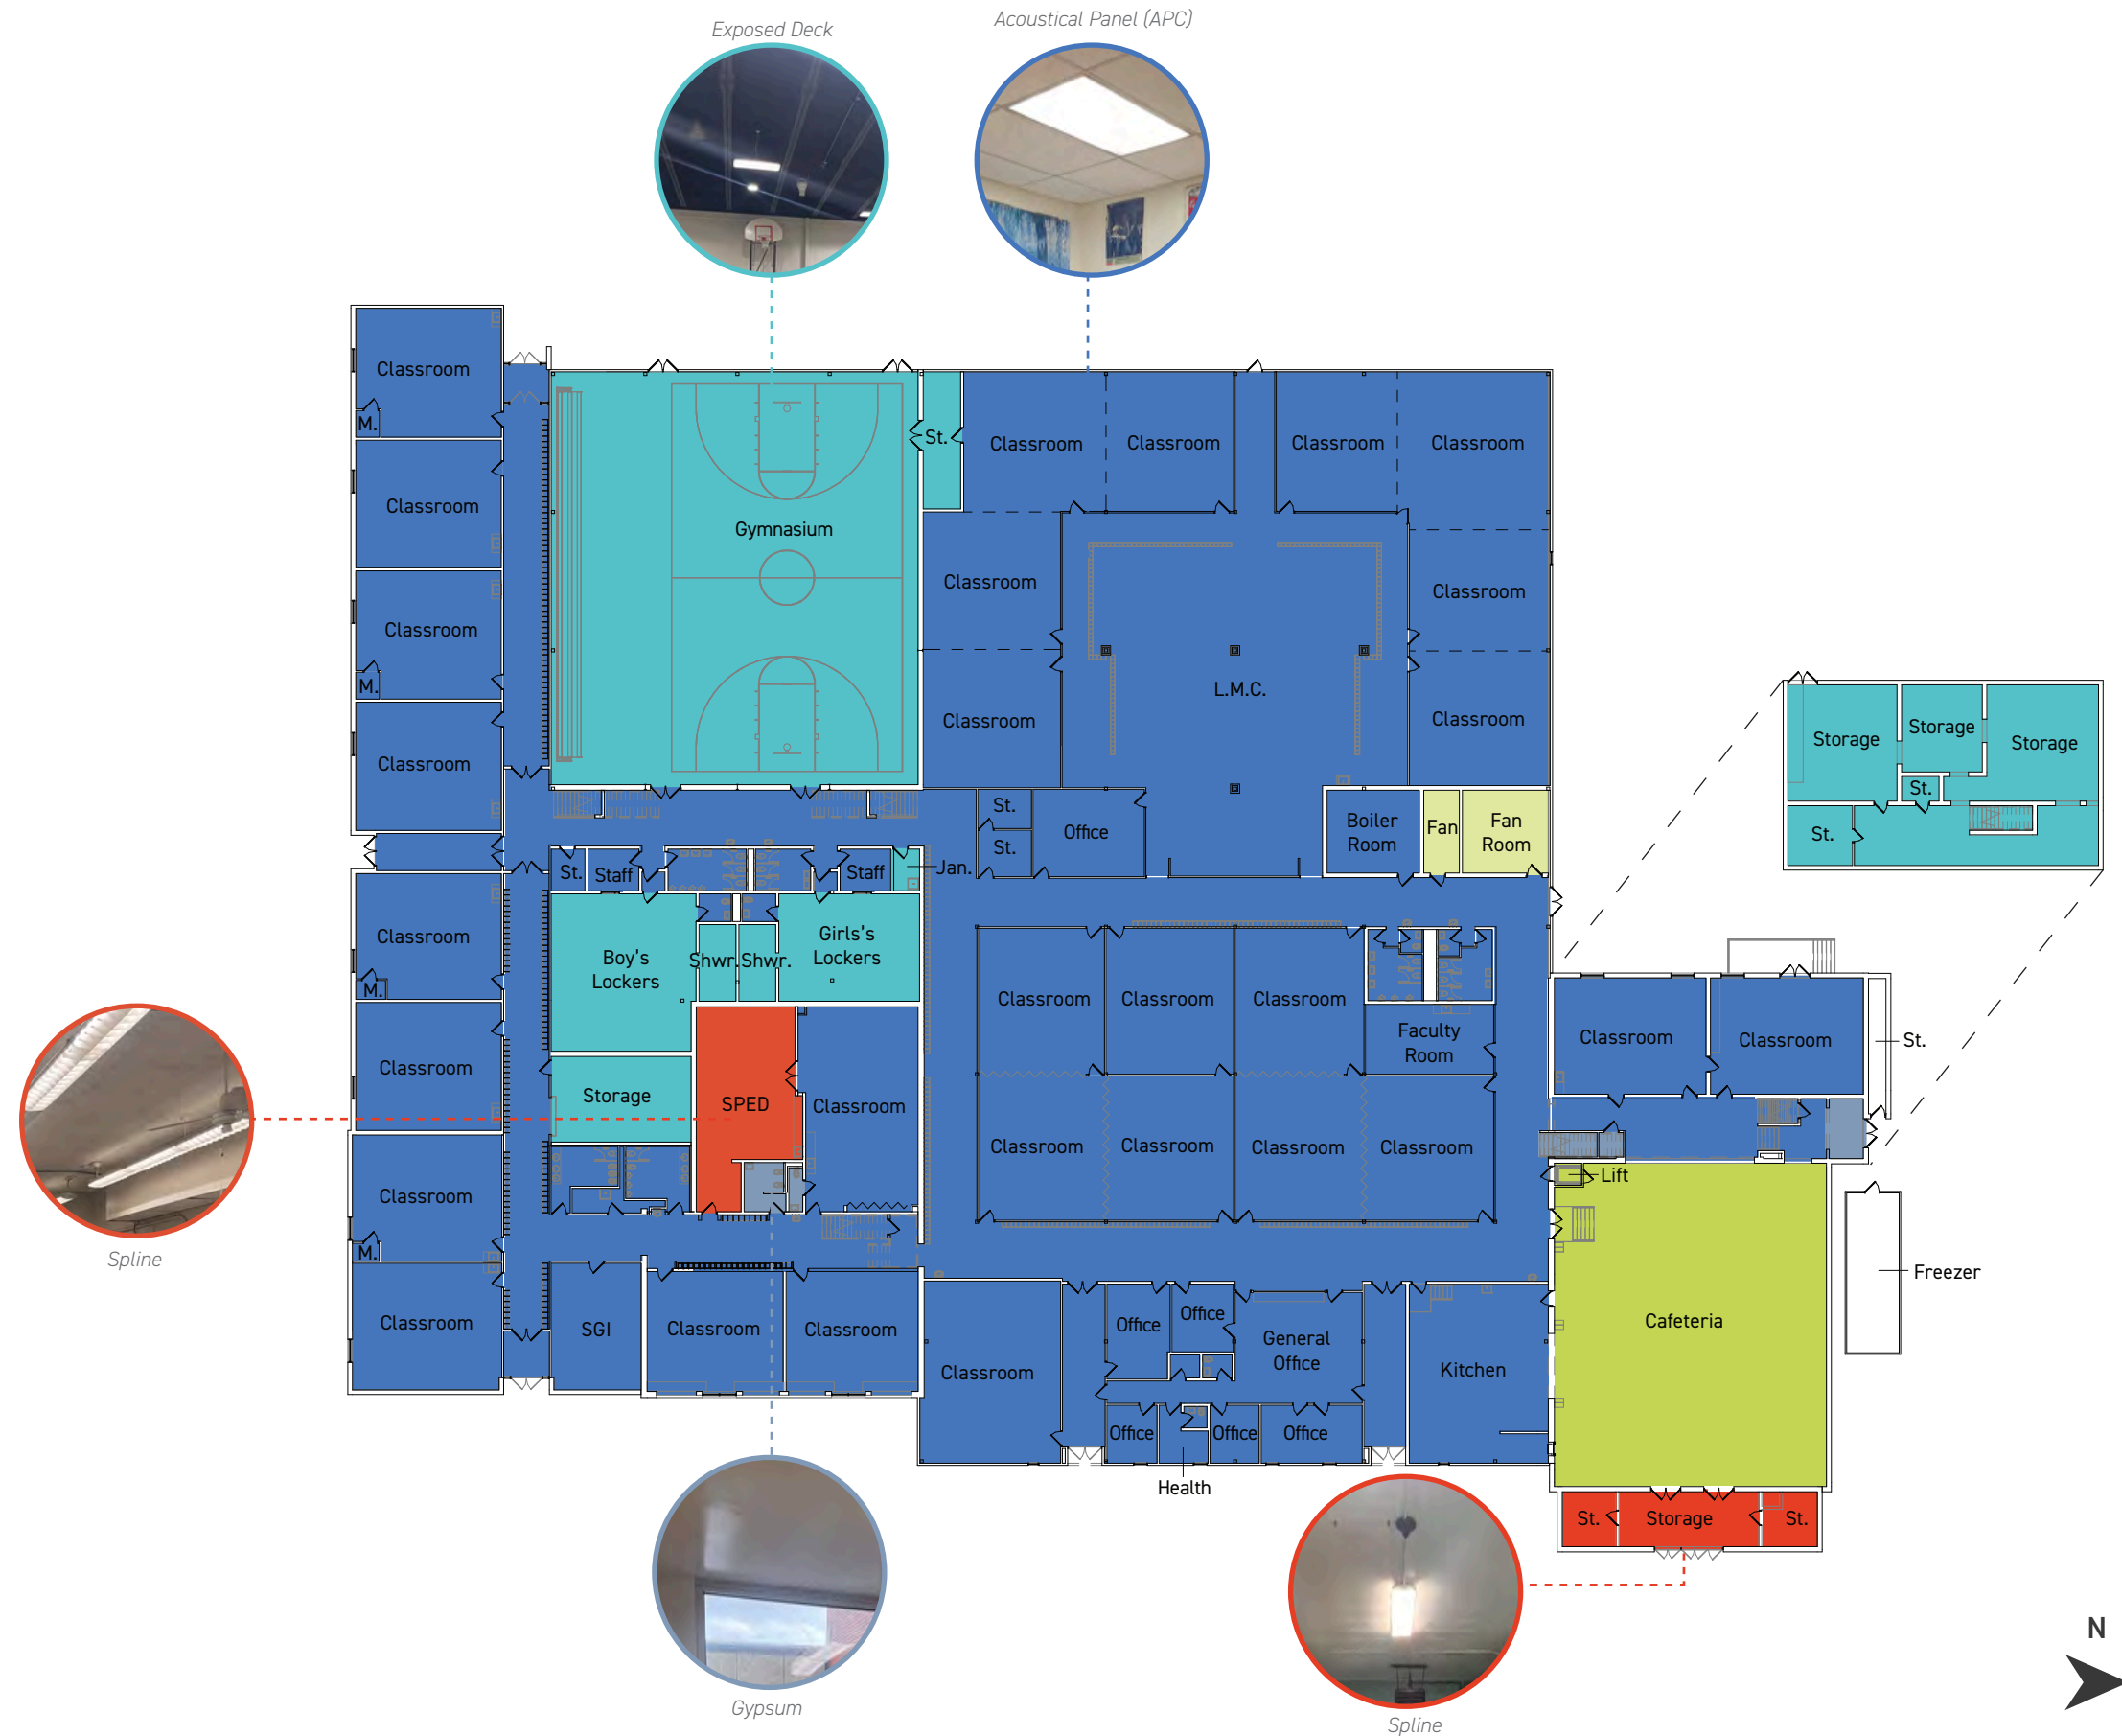
markesan elementary school ceiling material identification | first floor

- Materials identified as potentially containing asbestos are considered to be in poor condition.
- Spline ceilings are identified as a potential asbestos containing material.
- There is spline located in the Special Education Classroom on the first floor.
- Majority of the acoustical panel ceilings are in fair condition due to staining and/or cracking. Some acoustical panel ceilings are in poor condition due to excessive staining.

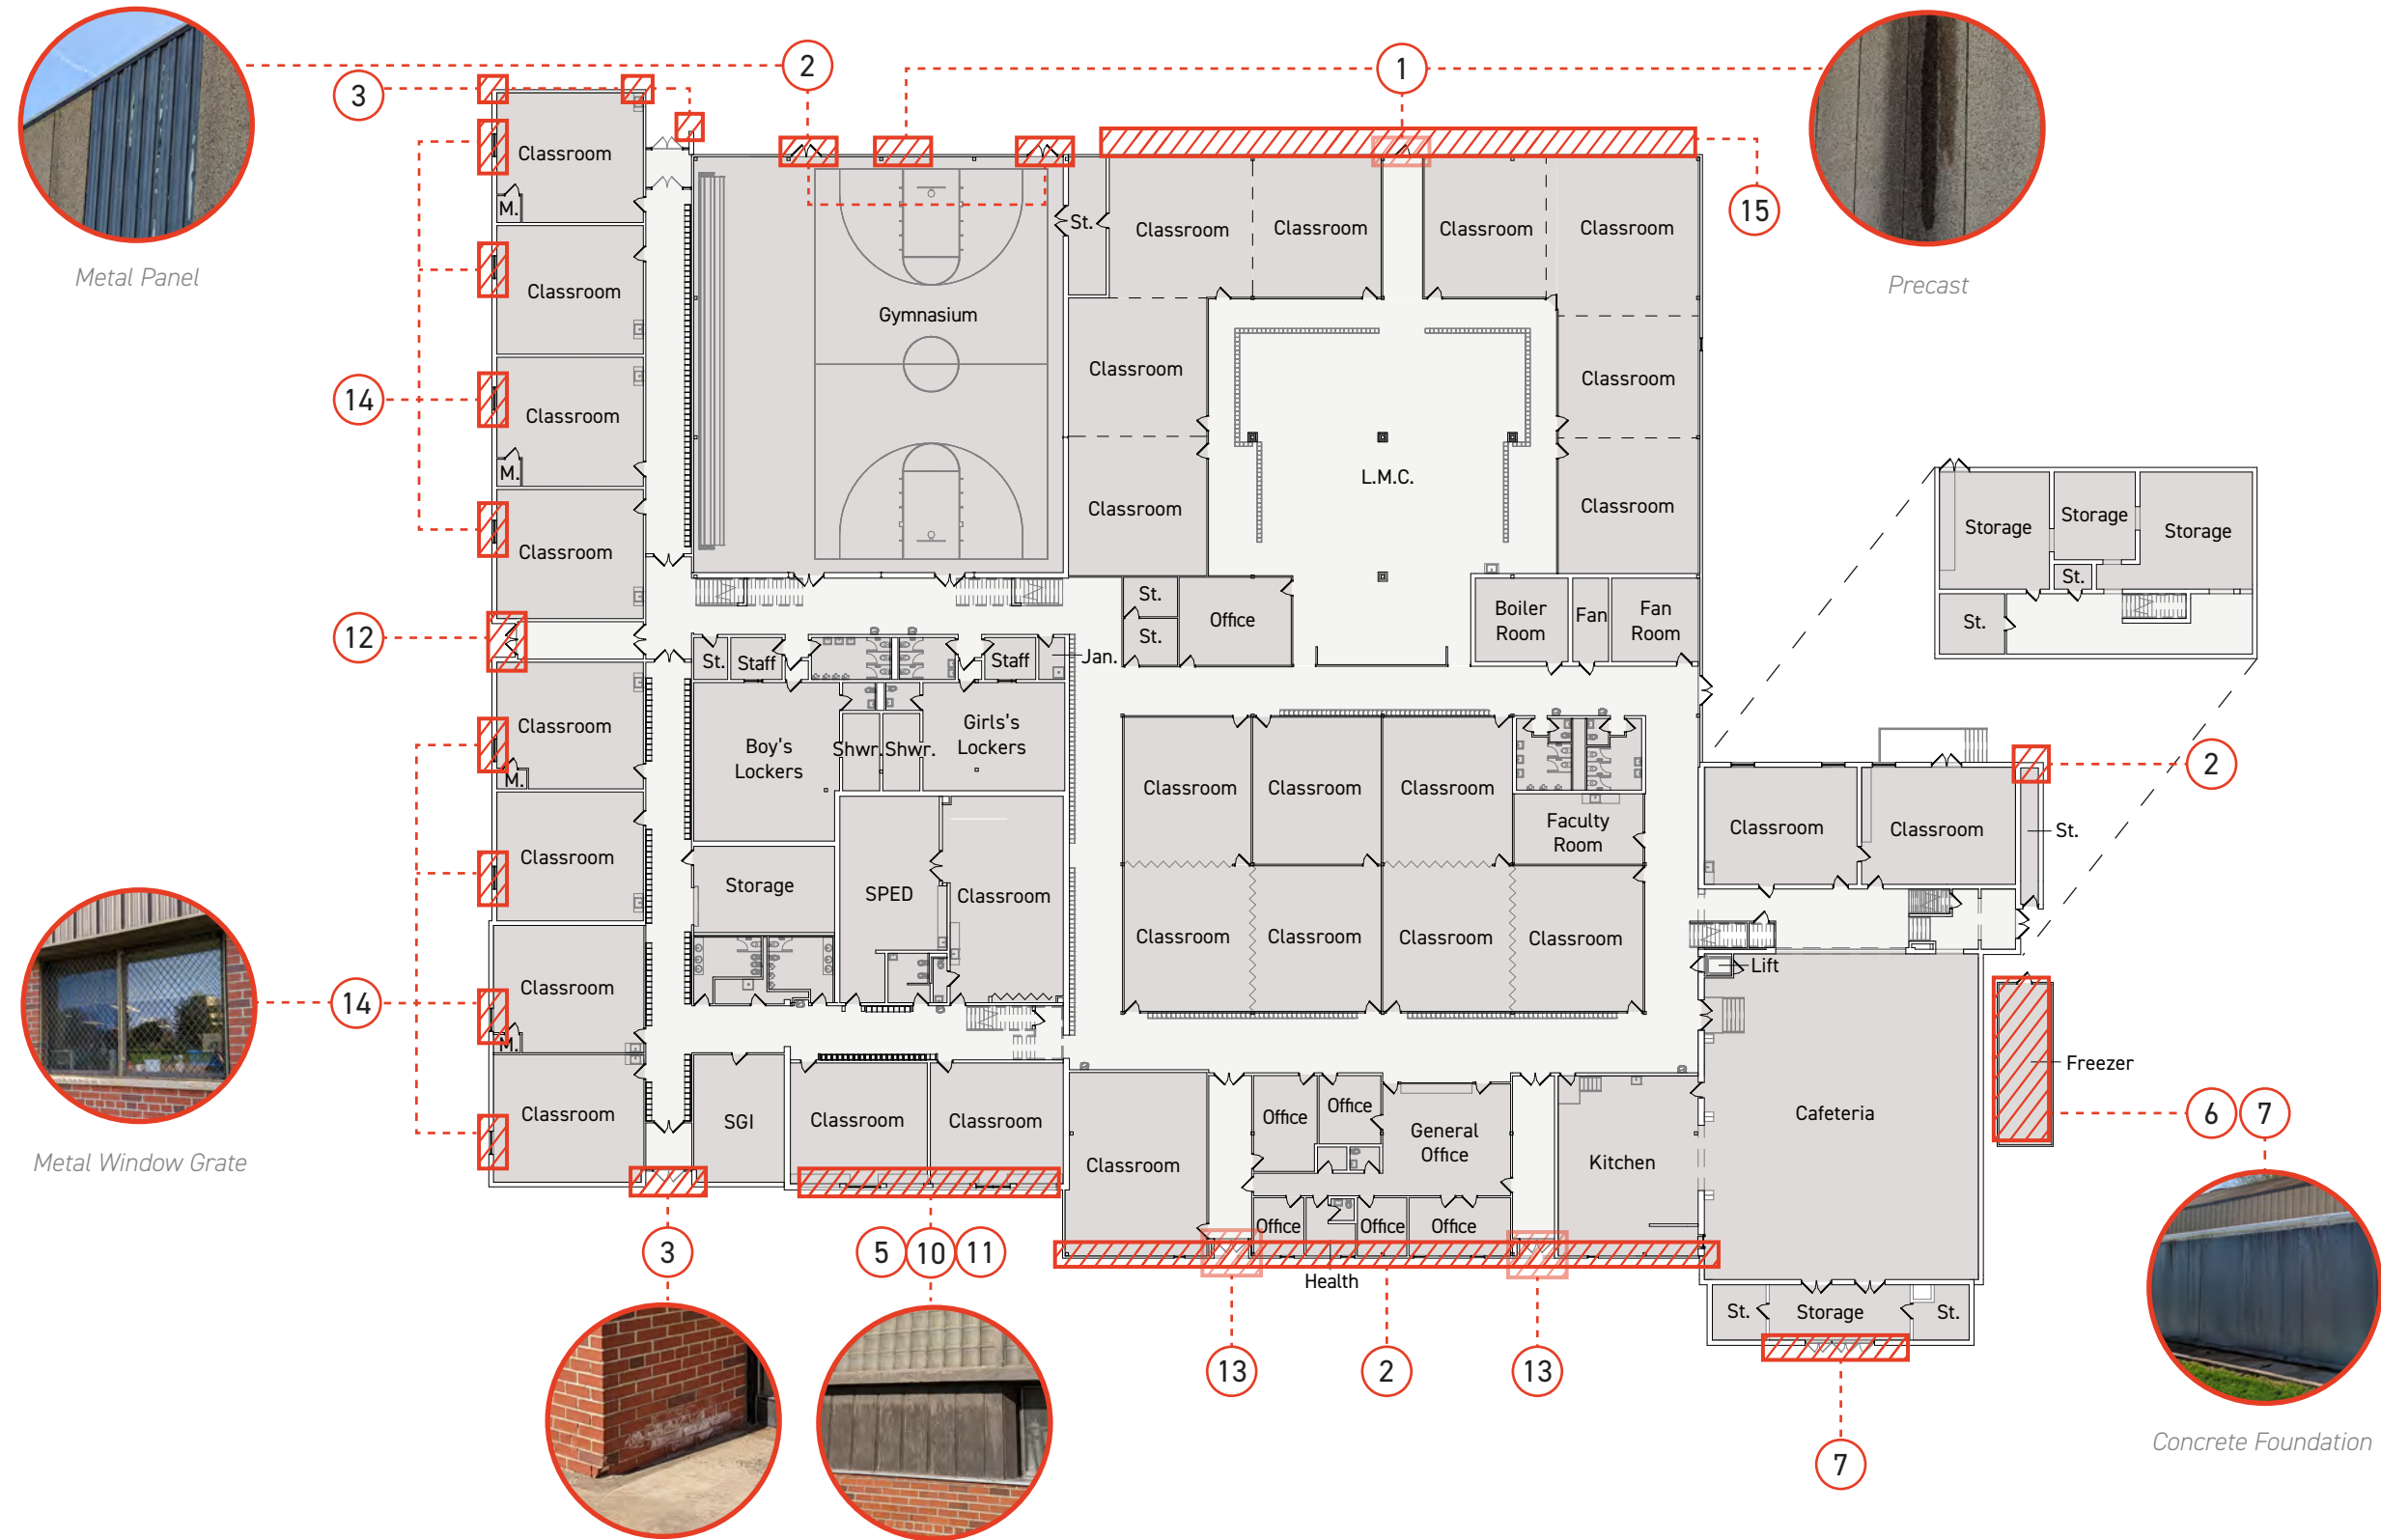
markesan elementary school exterior identifications + analysis | first floor

- Majority of the precast is in fair condition with some areas in poor condition due to staining and/or cracking.
- Majority of the brick is in fair condition. Some areas in poor condition due to cracking and/or crumbling.
- Majority of the metal panel is in fair condition due to peeling paint.
- Majority of caulking at wall joints is in poor condition due to deterioration.
- Some instances where the wood siding is in poor condition due to surface weathering.
- Metal grates on windows are in poor condition due to rusting.

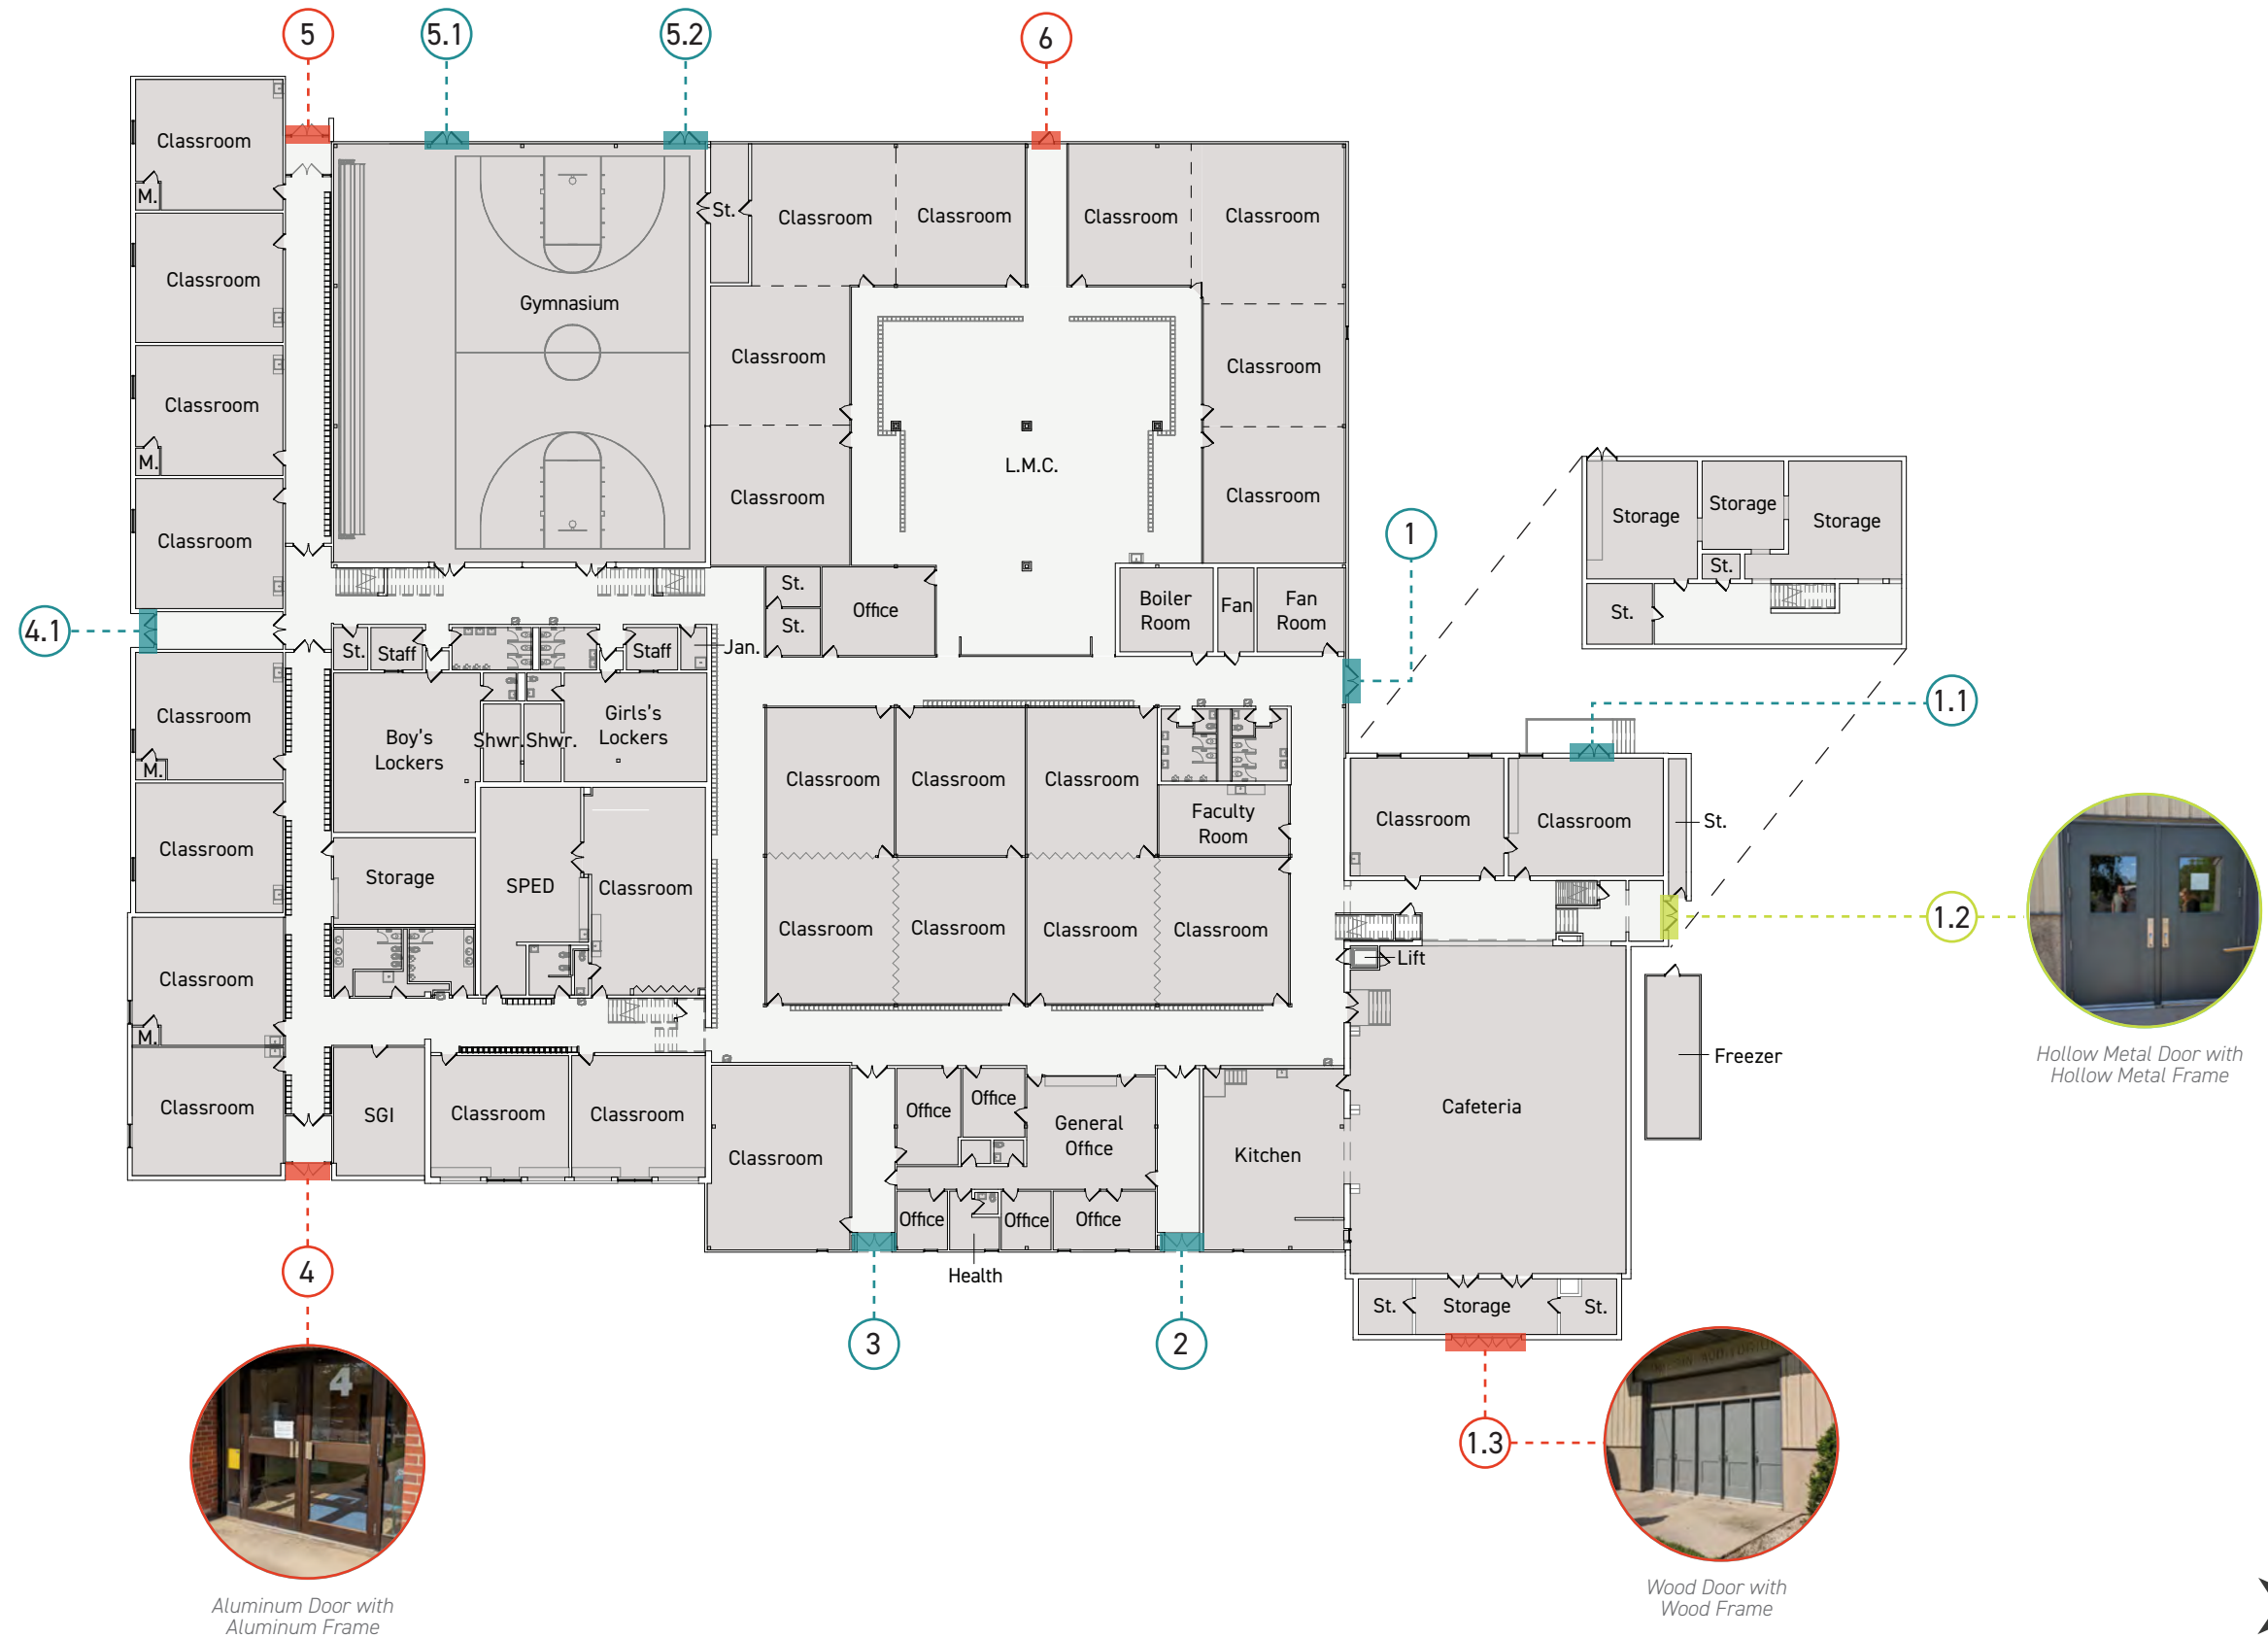
markesan elementary school exterior door identification + analysis | first floor

- Majority of the aluminum doors and frames are in good condition.
- Several instances where hollow metal doors are in poor condition due to rusting, weathering, surface scratches, paint peeling off and/or surface bubbling.
- Wood doors are in poor condition due to weathering, surface cracking, and paint peeling off.

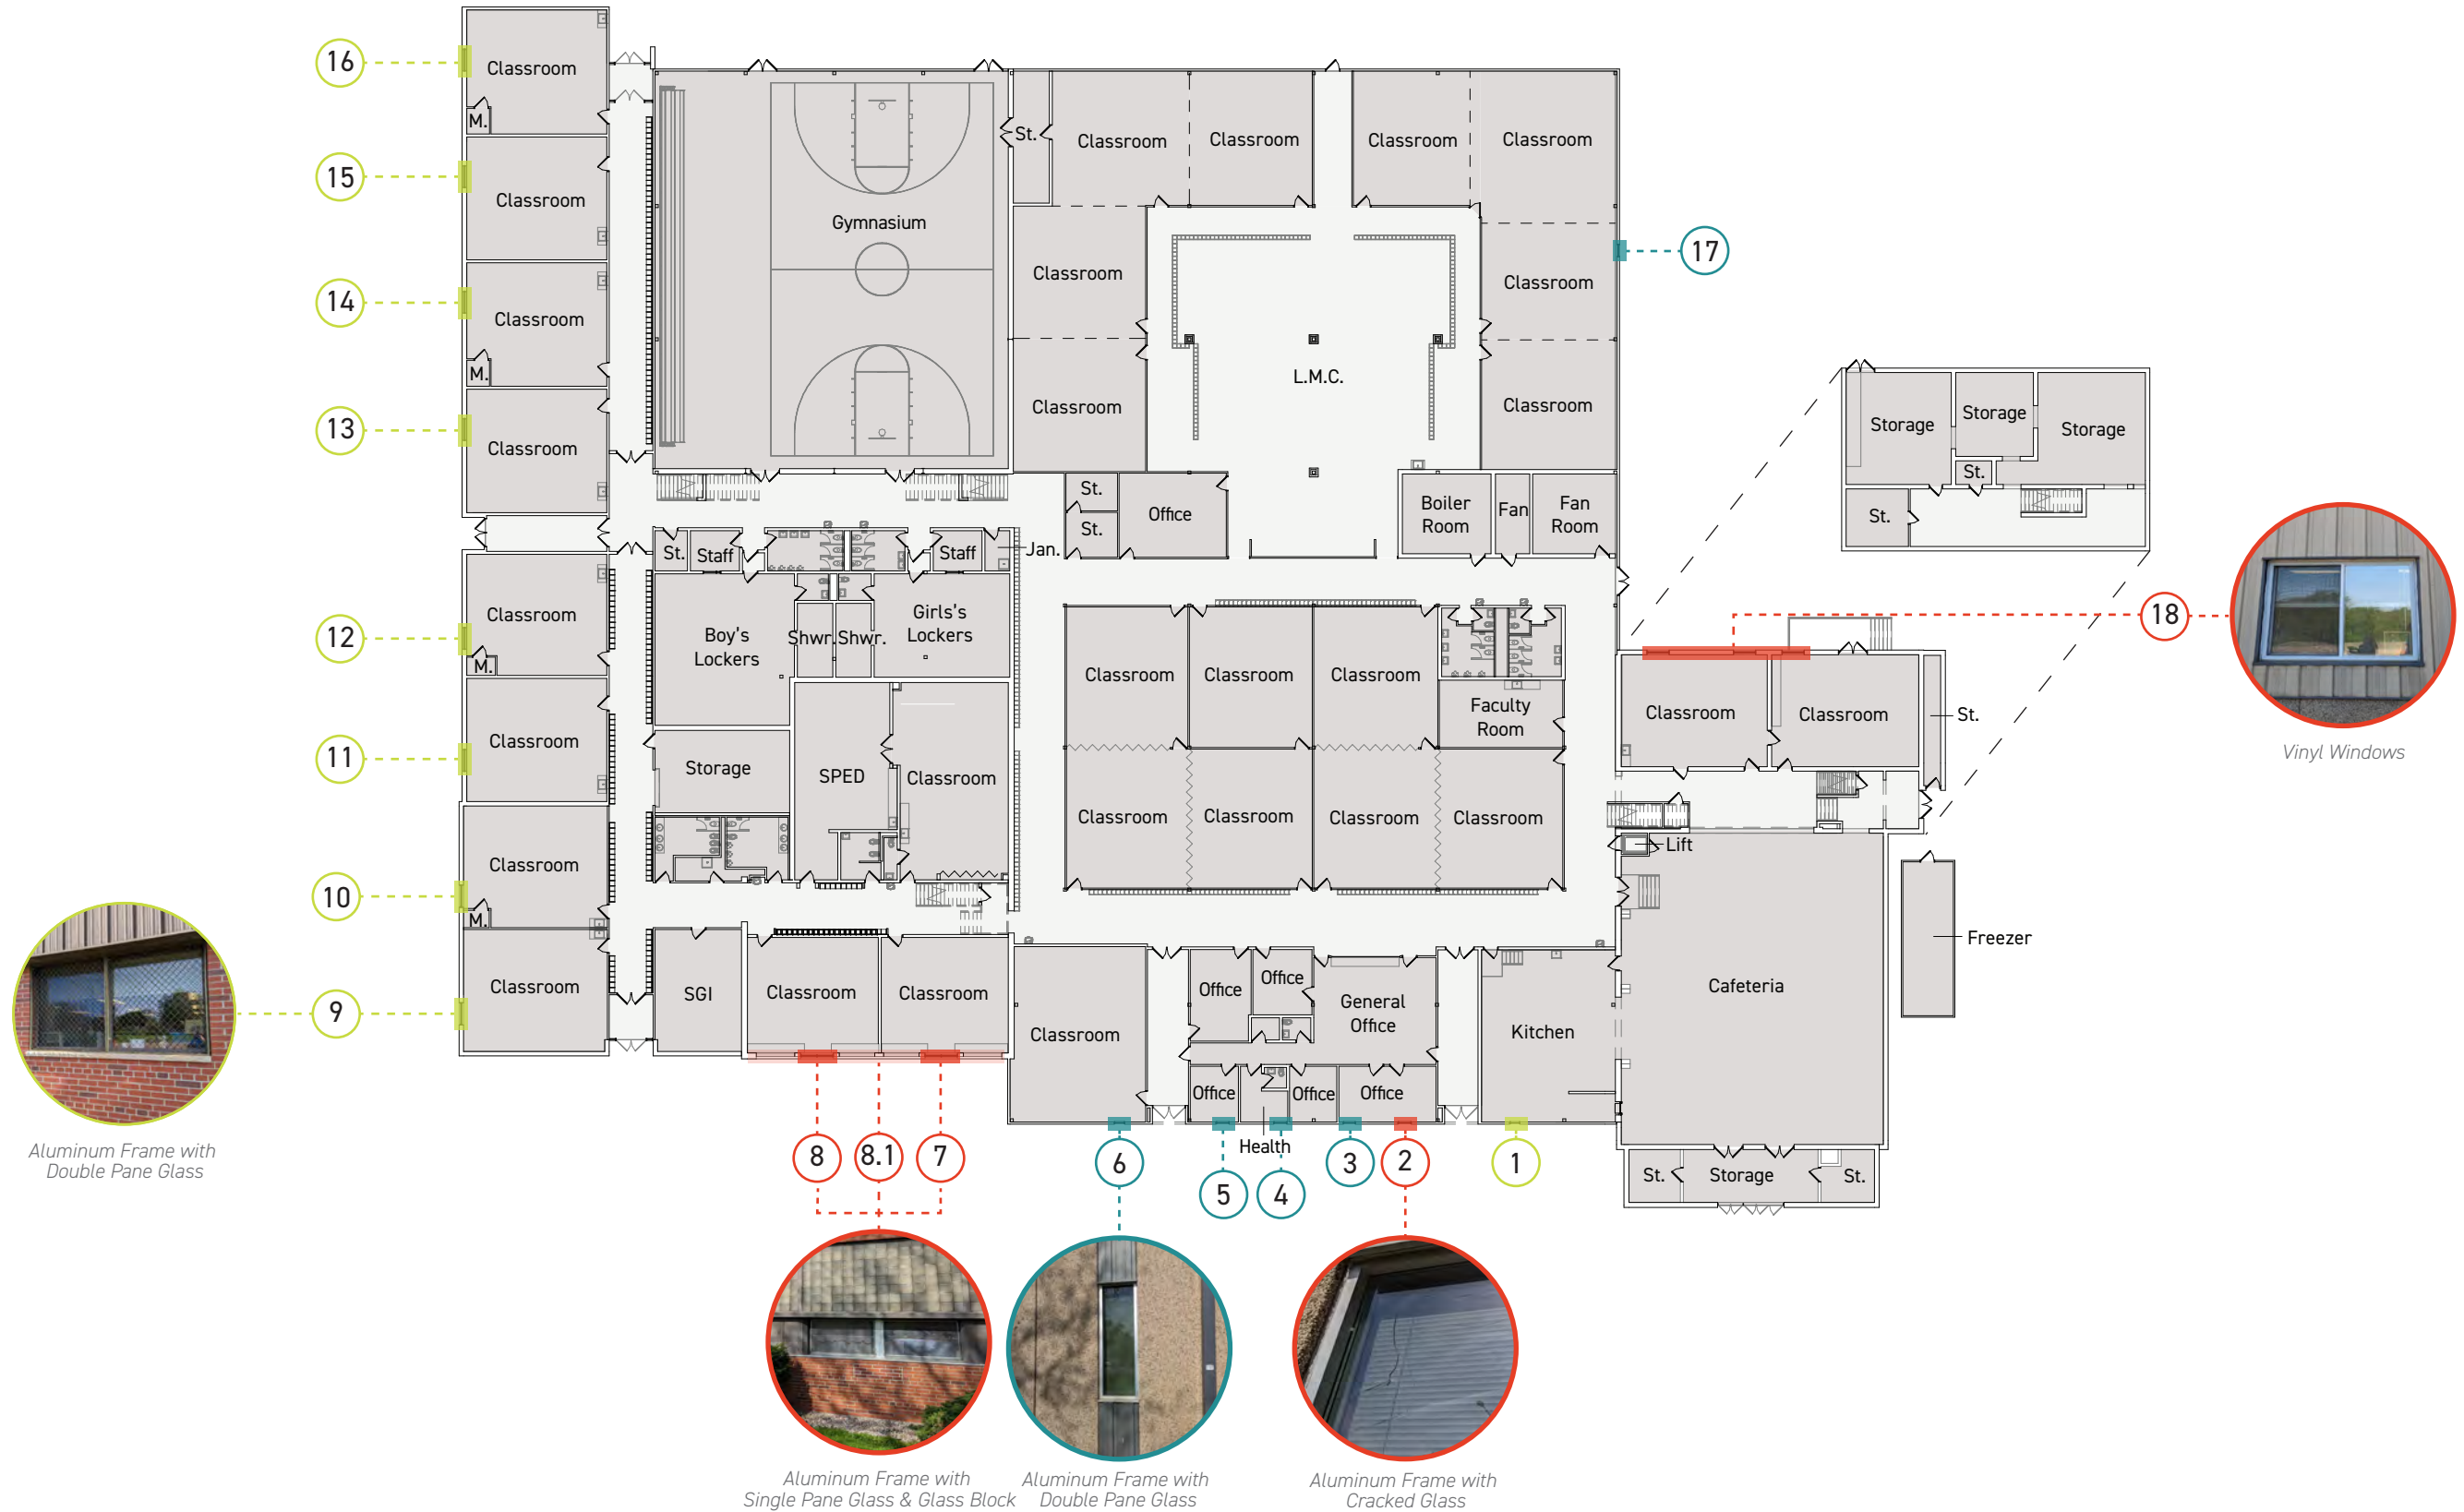
markesan elementary school exterior window identification + analysis | first floor

- Majority of the aluminum framed windows with double pane glass are in good condition.
- Majority of the vinyl windows are in poor condition due to weathering.
- Window #2 is in poor condition due to a crack in the glass.

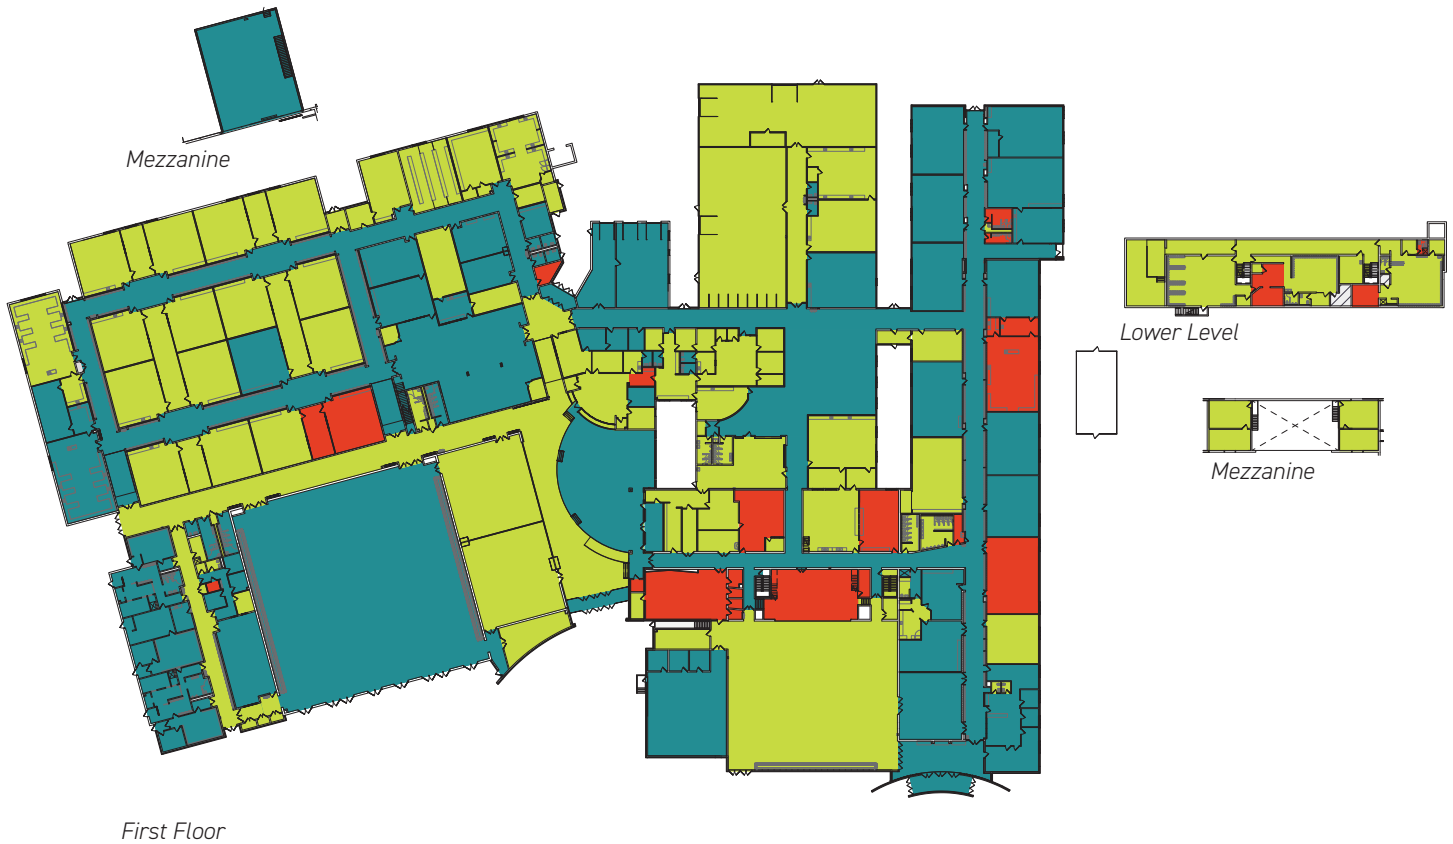
markesan middle/high school flooring analysis

- Materials identified as potentially containing asbestos are considered to be in poor condition.
- 9" x 9" vinyl tile flooring is identified as potential asbestos tile.
- There are a few areas such as classrooms in both the MS and HS that are used for other things than a classroom which have caused the intended flooring to become poor. i.e. classrooms as cardio or storage.
