Markesan District Schools

District-wide Facilities Study

STUDY DOCUMENT

July 2023

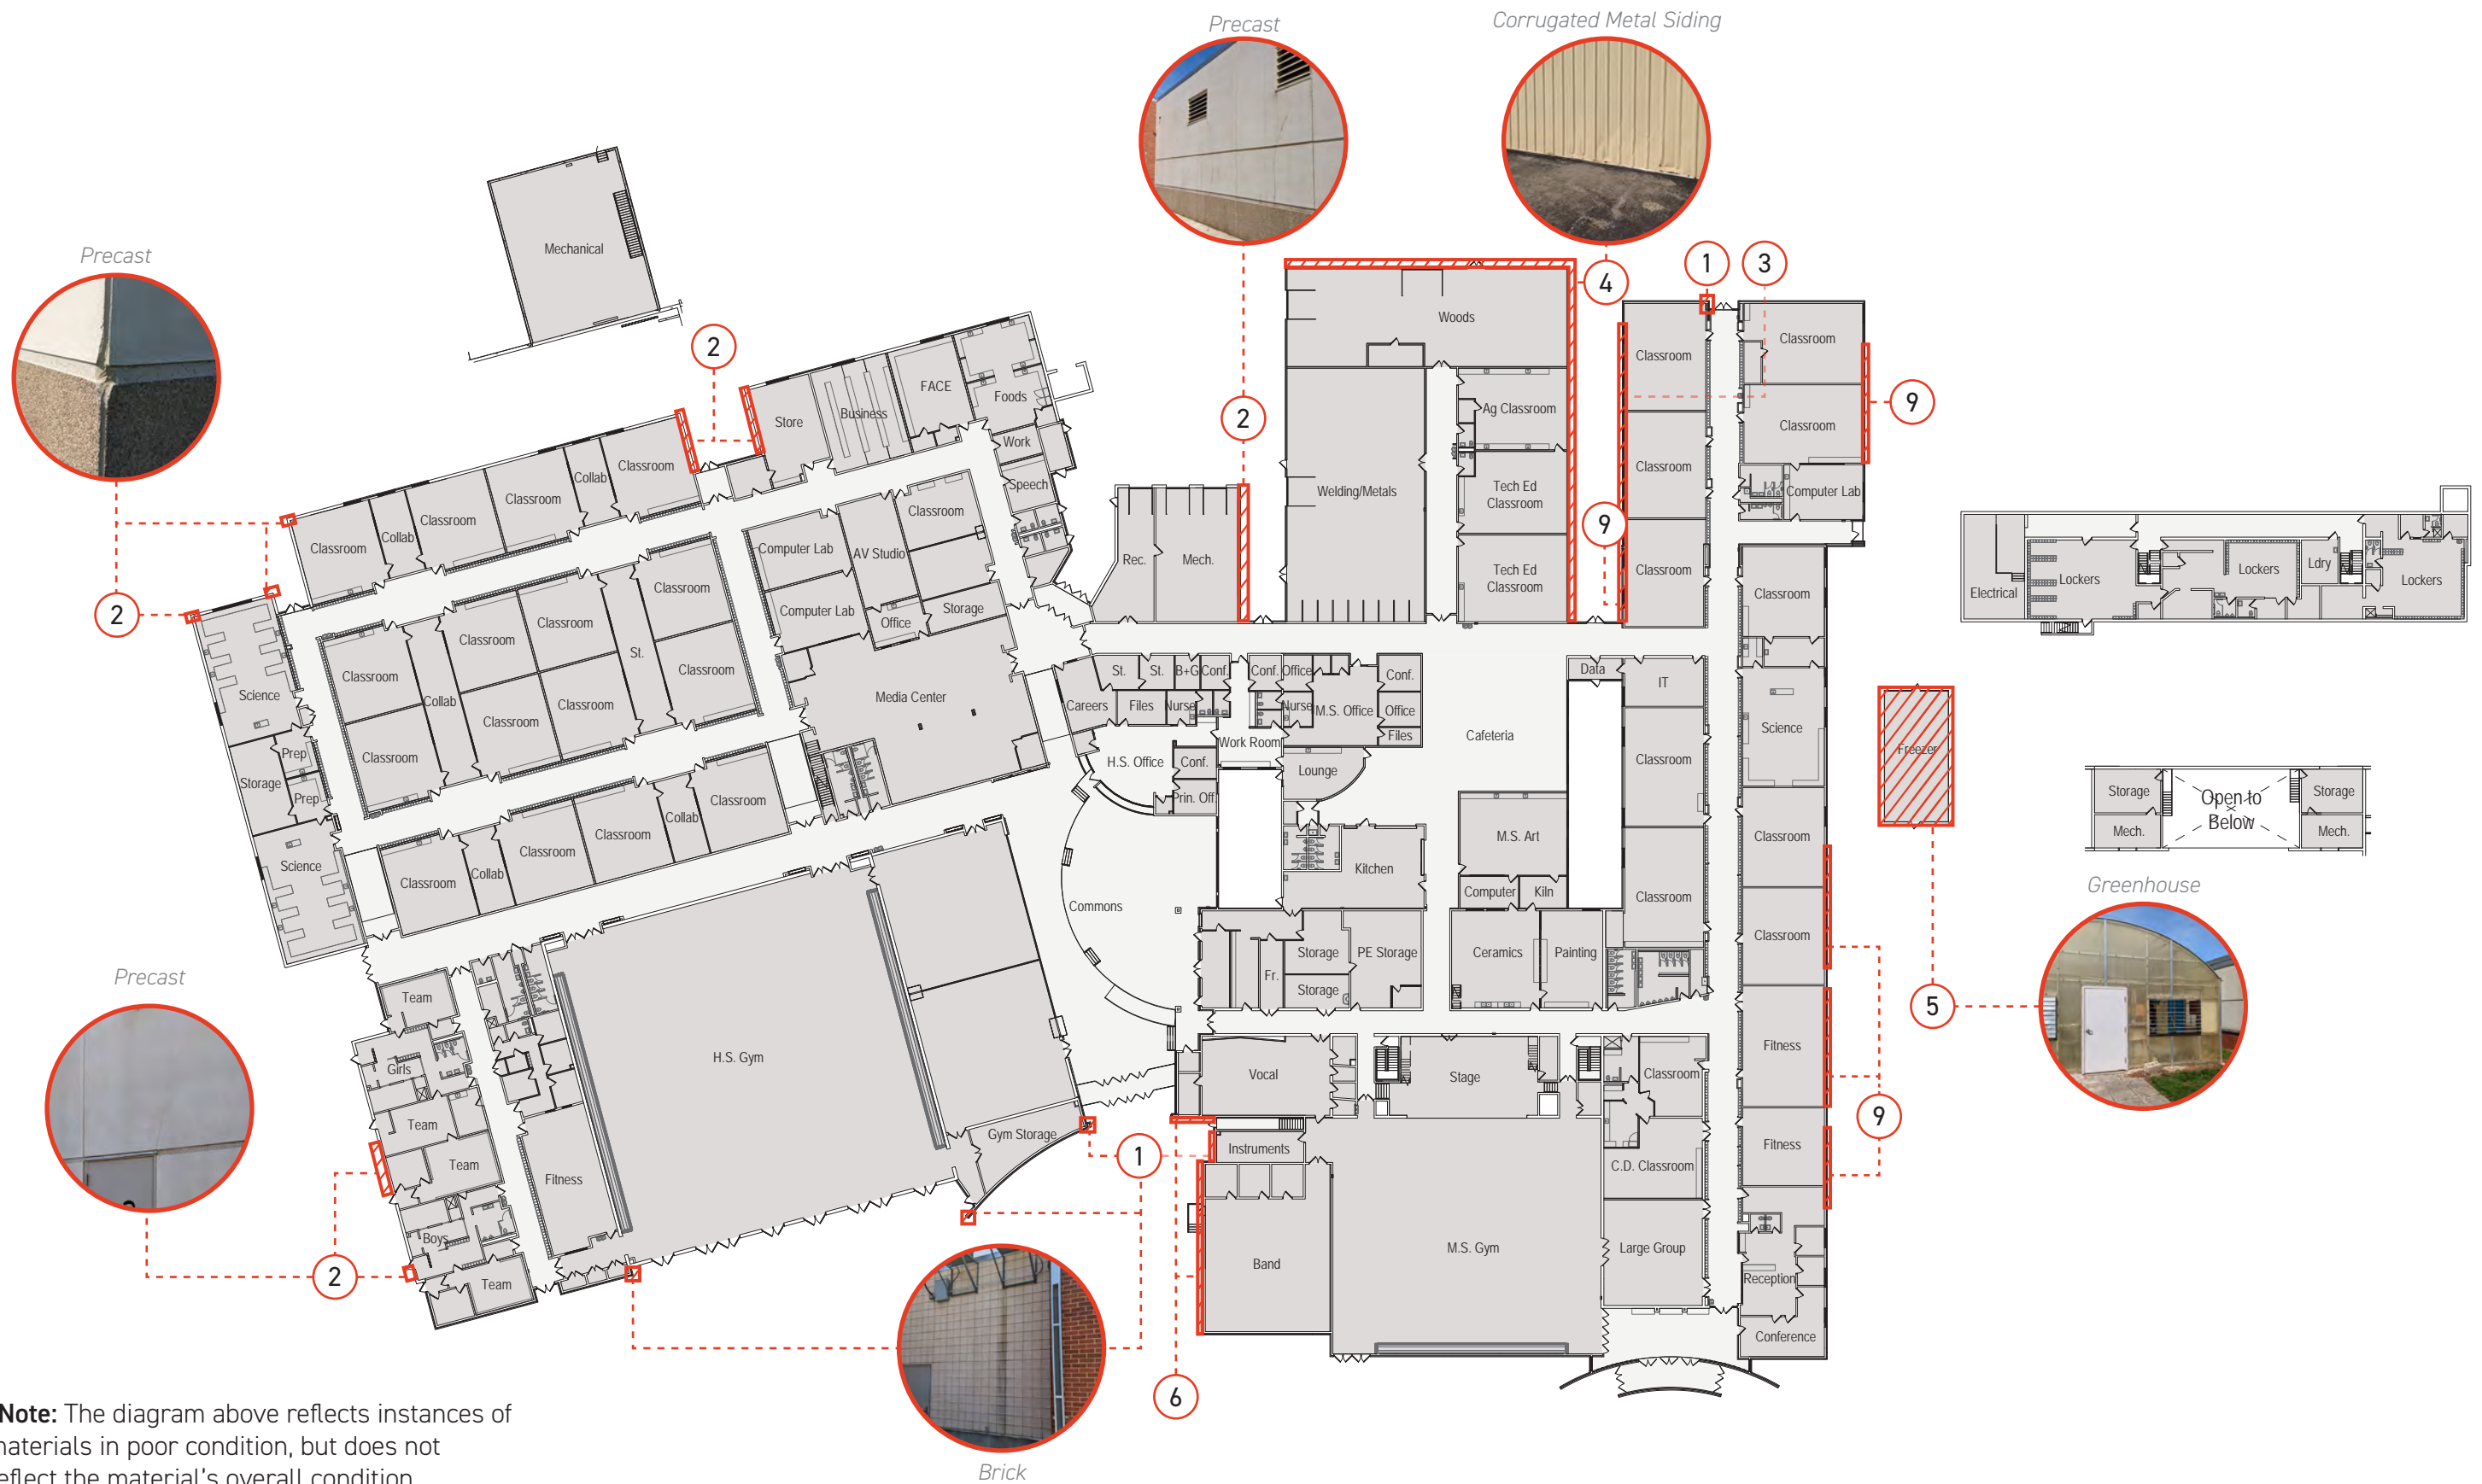
markesan middle/high school exterior identifications + analysis | first floor

- Majority of the brick is in good condition. There are a few areas in poor condition due to cracking and chipping, especially near corners.
- Majority of the precast is in fair condition due to cracking and staining, especially above doors and windows. There is one wall of the south boiler room in poor condition due to extensive cracking.
- Corrugated metal siding at the tech ed wing of the building is in poor condition due to rusting and/or denting, especially near the base of the wall.
- Cast stone sills are in fair condition as they appear to be holding shape, however all sills are stained.
- The greenhouse is in poor condition due to cracking and staining walls, dented louvers, and surface scratches on the doors.
- There are several instances where the insulation is exposed near the buildings foundation.

***Note:** The diagram above reflects instances of materials in poor condition, but does not reflect the material's overall condition.

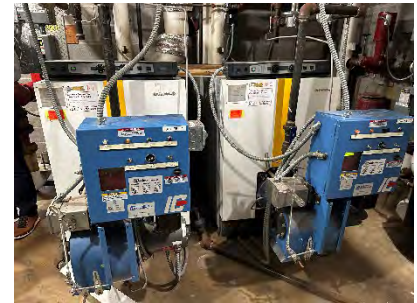
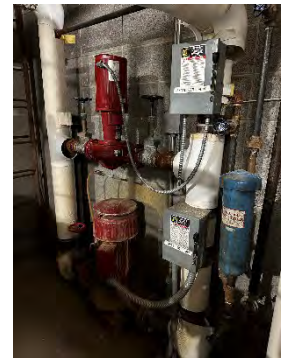
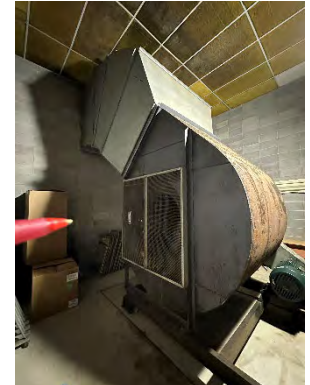
1. The boilers are believed to have been installed between 2010 and 2013 although the exact date is not known at this time. They appear to be in good condition. The boilers have all been well maintained. The ASHRAE service life expectancy is 20-25 years.
2. The hot water system pumps appear to be about 25 years old. Their ASHRAE service life expectancy is approximately 20-25 years.
3. The large JCI 50-ton condensing unit was recently installed in 2021. It is in excellent condition. The ASHRAE service life expectancy for this unit is approximately 20-25 years.

7. The residential furnaces and outdoor condensing units serving the 1990 addition vary in age with two (2) of the furnaces and condensing units installed in 2009 and two (2) furnaces and condensing units recently replaced in 2022. The units all appear to be in good condition. The ASHRAE service life expectancy for these units is approximately 15-20 years.

8. The Johnson Controls digital control system was installed in 2021 and is still getting some final programming completed.

1. Continue with preventive maintenance on all equipment to maximize life expectancies.
2. Plans should be made for the removal and replacement of the 1973 air handling unit currently serving the largest portion of the building with a high-efficiency unit with a direct-drive fan, variable air volume (VAV) control, and a variable frequency drive to control fan motor speed. At that time, the duct-mounted hot water booster coils would be replaced with variable air volume (VAV) boxes with hot water reheat coils to provide a complete VAV system to significantly improve energy efficiency and system performance.

3. Install multiple variable speed roof exhaust fans for building pressure control utilizing variable frequency drives on the fan motors and building static pressure sensors.

4. Remove the existing boilers and constant flow pumping system and replace with a new high-efficiency boiler plant consisting of multiple condensing hot water boilers and a variable speed pumping system.

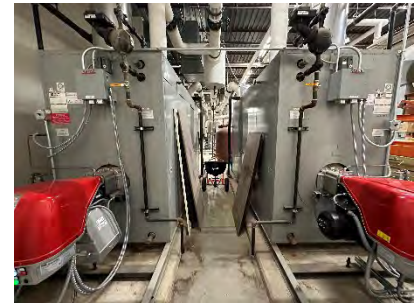
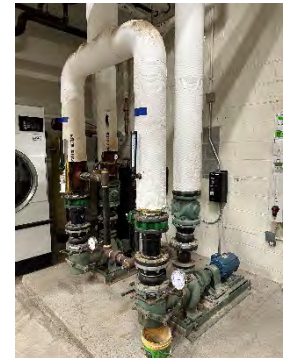
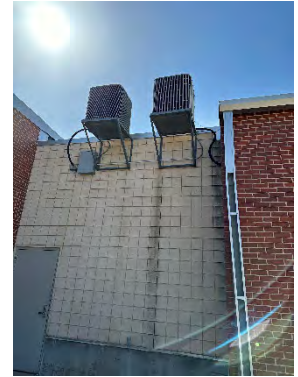
1. The boilers were installed in 1999 and are in good condition. The boilers have all been well maintained. The boilers were more recently retrofitted with Riello high-efficiency burners that are in excellent condition. The flexible tube boiler ASHRAE service life expectancy is 30-35 years.
2. The hot water system pumps are also from 1999 and appear to be in good condition. However, their ASHRAE service life expectancy is approximately 20-25 years.
3. The air-cooled chiller was recently installed in 2021 to replace the previous unit and is in excellent condition. The ASHRAE service life expectancy for this chiller is approximately 25-30 years.

8. The fan coil units serving the Woods and Metals shops were recently installed in 2021 and are in very good condition. The ASHRAE service life expectancy for these units is approximately 15-20 years.

9. The Johnson Controls digital control system was installed in 2021 and is still getting some final programming completed.

1. Continue with preventive maintenance on all equipment to maximize life expectancies.
2. Plans should be made for the removal and replacement of the 1959 air handling units currently serving the middle school gymnasium with high-efficiency units with direct-drive fans, variable air volume (VAV) control, and variable frequency drives to control fan motor speed.
3. Plans should be made for the eventual replacement of the roof-mounted air handling units.
4. Remove the existing blower coil units and outdoor condensing units that currently serve the Band and Vocal rooms. Install new roof-mounted, packaged units with hot water and chilled water coils and variable speed, direct-drive fans.
